ESSO PIPELINE REPLACEMENT PROJECT	ANNUAL COMPLIANCE REPORT

ESSO PIPELINE REPLACEMENT PROJECT (EPBC 2014/7202)

ANNUAL COMPLIANCE REPORT # 3

EMEL-RPT-355-EN203

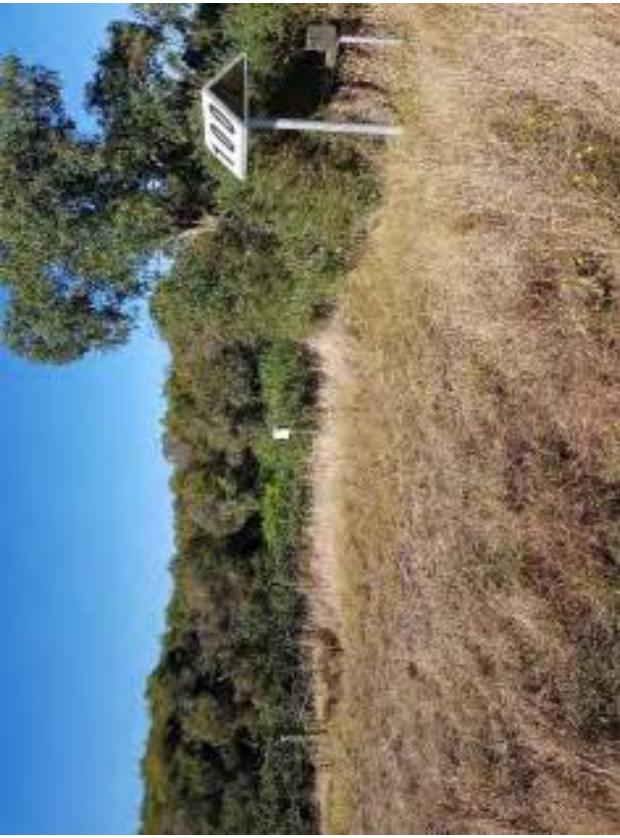
ESSO PIPELINE REPLACEMENT PROJECT		REVEGETATION RECORD	ESSO
MONITORING POST PLANTING			
Milestone: 6 months Target: N/A – pasture only	Date: 08/03/2018	Area of undisturbed vegetation (primarily weed species) identified as SBB habitat remains, with additional growth. Pasture grasses established with ~100% coverage across reinstated RoW.

<p>Photo 1: Photo looking west.</p>
Milestone: 12 months Target: 60% cover over 90% area Date: 24/09/2018		Site not revisited - area identified as SBB was not disturbed by construction and revegetation not required, as per findings of 6-month inspection - Pasture grasses established with ~100% coverage across 100% of reinstated RoW area.	
Milestone: 2 years Target: 90% survival Date: N/A		Site not revisited - area identified as SBB was not disturbed by construction and revegetation not required, as per findings of 6-month inspection

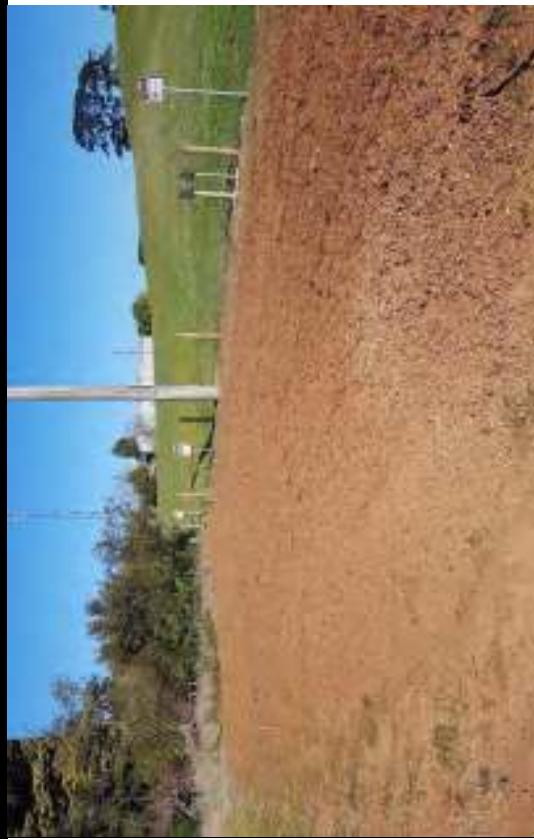
Photo 3:
Westernport Road – western
roadside (facing south)

The area on the western roadside has been recently worked to loosen the soil and replanted with tubestock, following low survival of the original planting. Plants have yet to establish any assessable cover. Conditions remain very dry, despite the season.

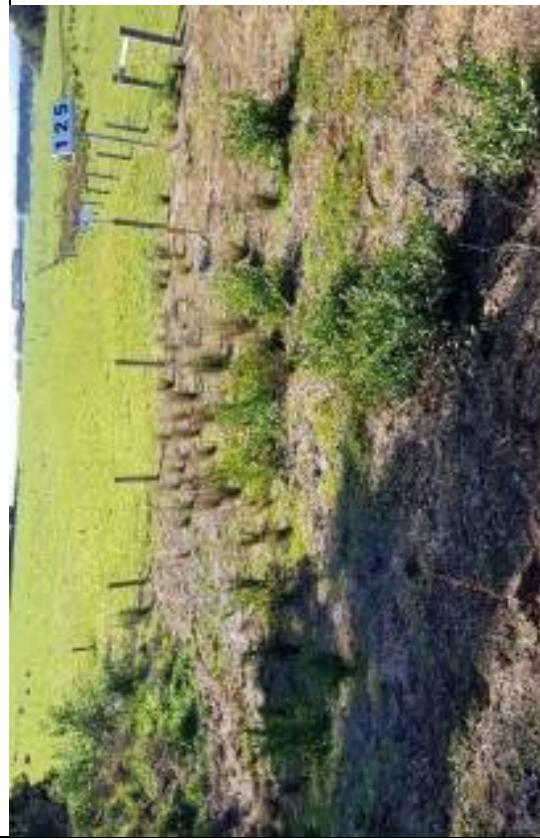
Photo 4:
Westernport Road – eastern
roadside (facing east)

On the eastern roadside survival remains at ~80%. Grasses have not grown substantially over winter. Shrubs and creepers have grown, with cover estimated at 60% over this half of the site.

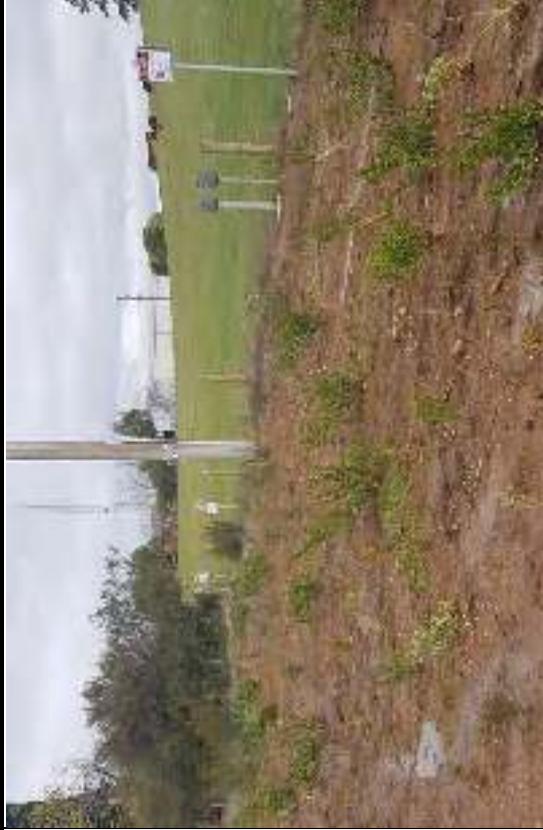
<p>The area on the western roadside 100% of expected plant density within the revegetation area. This is primarily 12-month-old replanting following low survival of the original planting. Cover remains low as plants are establishing, but is expected to increase significantly with spring growth.</p>

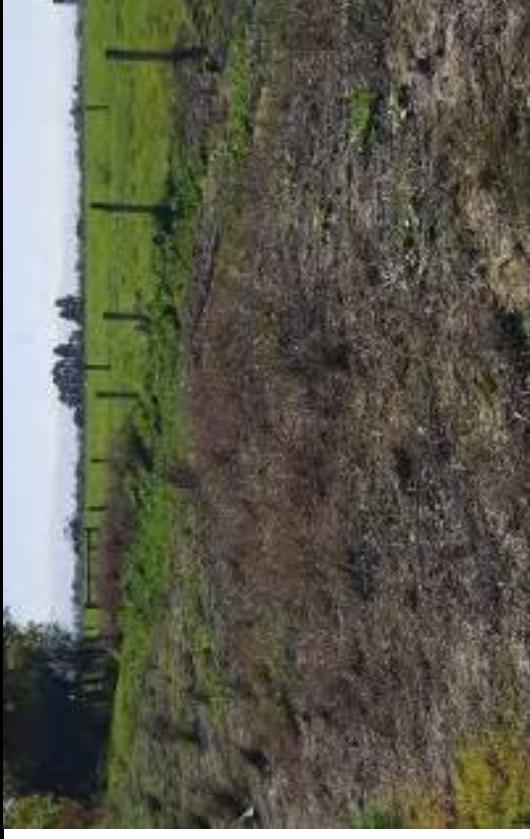
ESSO PIPELINE REPLACEMENT PROJECT	REVEGETATION RECORD	ESSO
<p>MONITORING POST PLANTING</p> <p>Milestone: 12 months Target: 60% cover over 90% area Date: 13/09/2018</p> <p>Survival on the eastern roadside is low (~50%) there has been little growth and phragmites has died back. Some supplementary planting is evident but has not yet established any assessable cover. Cover is less than 50%.</p> <p>Survival on the western roadside is ~80% and there has been moderate growth of plants. Cover is ~60%.</p>

<p>Photo 3: Caldermeade Road. Eastern side, facing north. Shows slashed access track.</p>

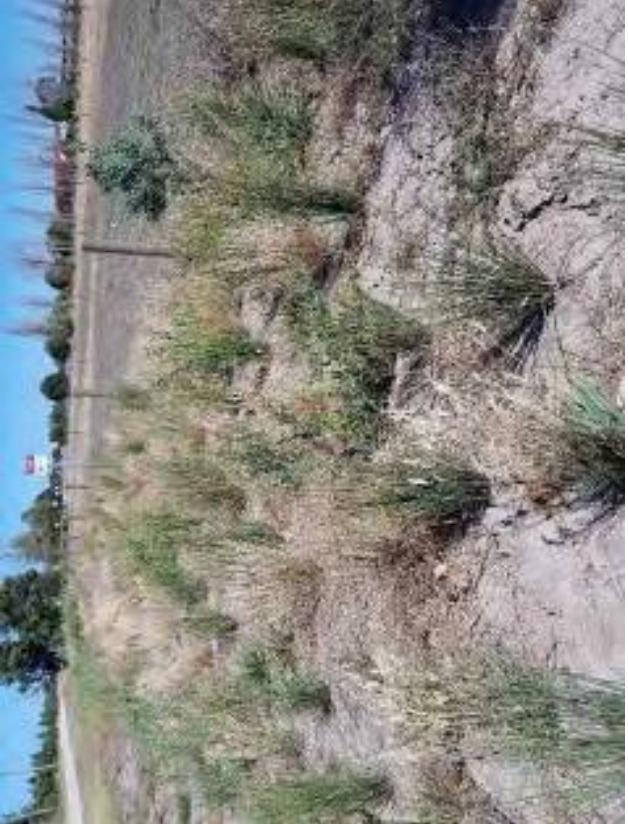
Photo 1: Hall Rd, north side, looking west.

ESSO PIPELINE REPLACEMENT PROJECT		REVEGETATION RECORD	ESSO
VEGETATION			
Location	Hall Rd, KP141		
Sensitivity	Southern Brown Bandicoot Habitat		
Approval	EPBC Referral 2014/77202		
VEGETATION			
Date	21/07/2017		
Area	0.036 ha tubestock		
Notes	North roadside only, from drain to fence line and full width of the RoW.		
MONITORING POST PLANTING			
Milestone: 6 months			
Target: 80% survival			
Date: 06/03/2018			
	Very good survival and growth across the site. Estimated survival is 95%.

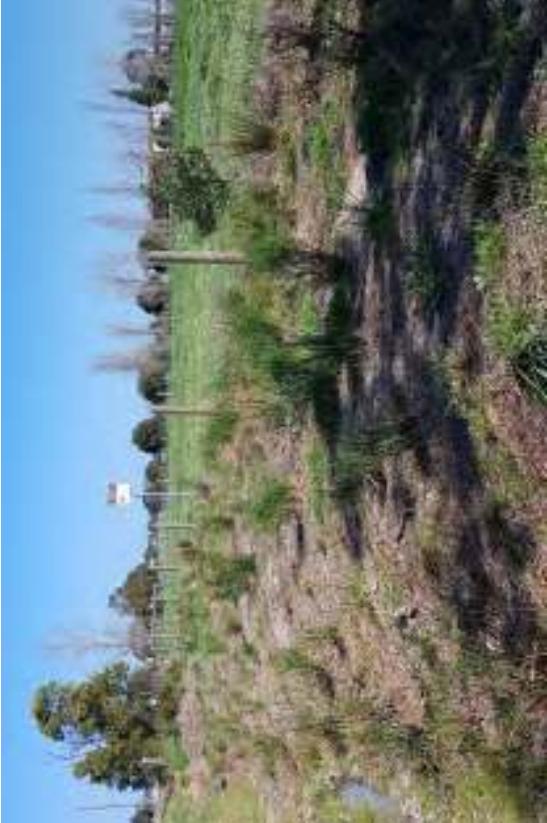
<p>Photo 2: Hall Rd, north side, looking west.</p>

ESSO PIPELINE REPLACEMENT PROJECT	REVEGETATION RECORD
<p>Milestone: 12 months Target: 60% cover over 90% area Date: 13/09/2018</p> <p>Survival has decreased since the 6-month survey and there has been little growth over winter. Cover is estimated to be at least 60% across the site.</p>

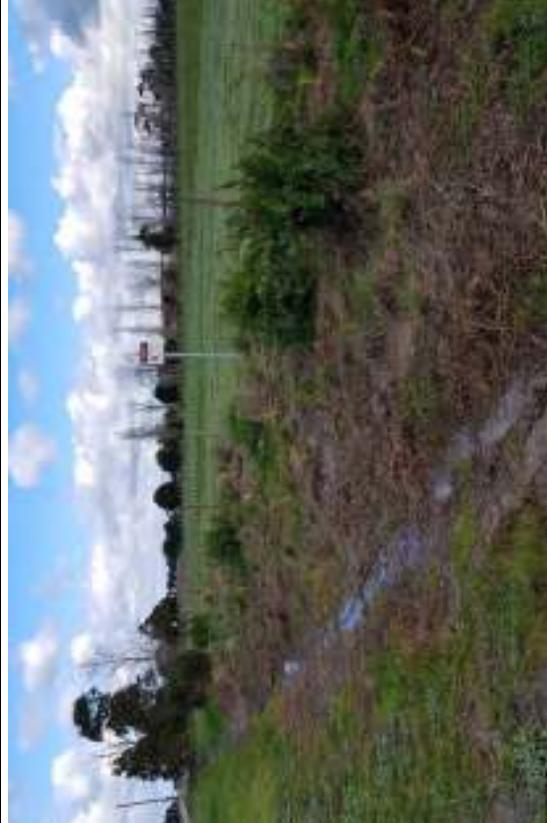
<p>Photo 3: Hall Rd, north side, looking west.</p>
---	--

<p>Milestone: 2 years Target: 90% survival Date: 08/08/2019</p> <p>Grasses and rushes planted along the edge of the drain appear to have been slashed, most likely during council maintenance of vegetation in the drain. Survival of original planting is estimated to be ~60%. With maintenance planting, this area has 90% of the expected plant density within the revegetation area. Grasses and rushes have undergone seasonal senescence and winter dormancy, but will increase coverage in spring.</p>

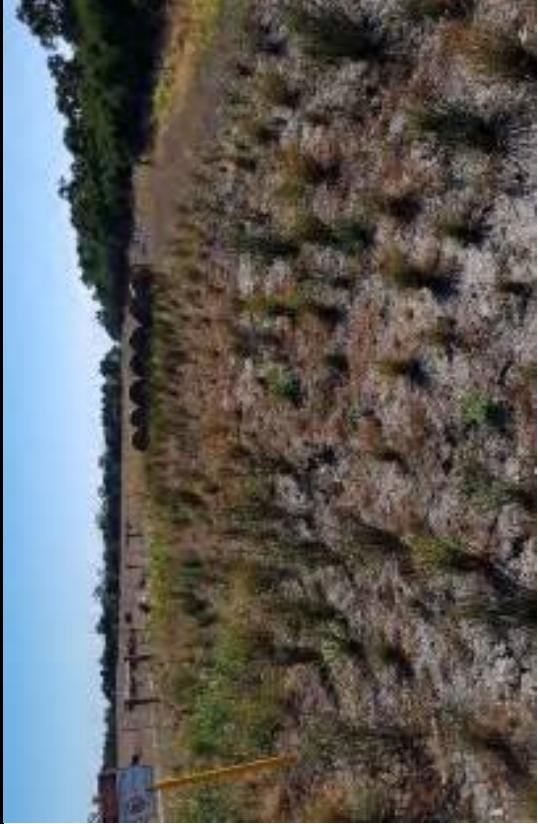
<p>Photo 2: Railway Rd. KP154.8, facing east. Grazed RoW.</p>

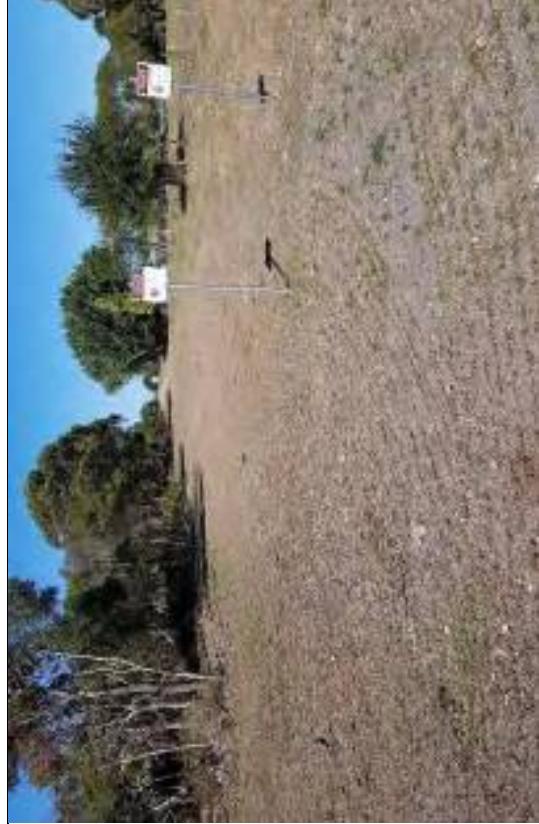
<p>ESSO PIPELINE REPLACEMENT PROJECT</p>	<p>REVEGETATION RECORD</p>	<p>MONITORING POST PLANTING</p>
		<p>Photo 3: Railway Rd. KP156, facing east. Mowed RoW.</p>

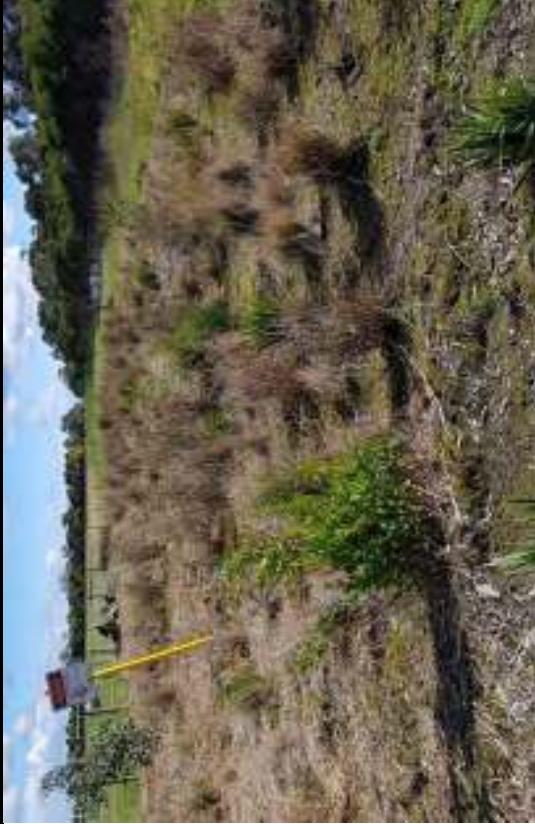
ESSO PIPELINE REPLACEMENT PROJECT	REVEGETATION RECORD	
MONITORING POST PLANTING	<p>Milestone: 2 years Target: 90% survival Date: 08/08/2019</p> <p>Overall, there is >90% of the expected plant density within the remaining tubestock revegetation areas.</p>	<p>Photo 1: Railway Rd. KP153.5. facing west.</p>

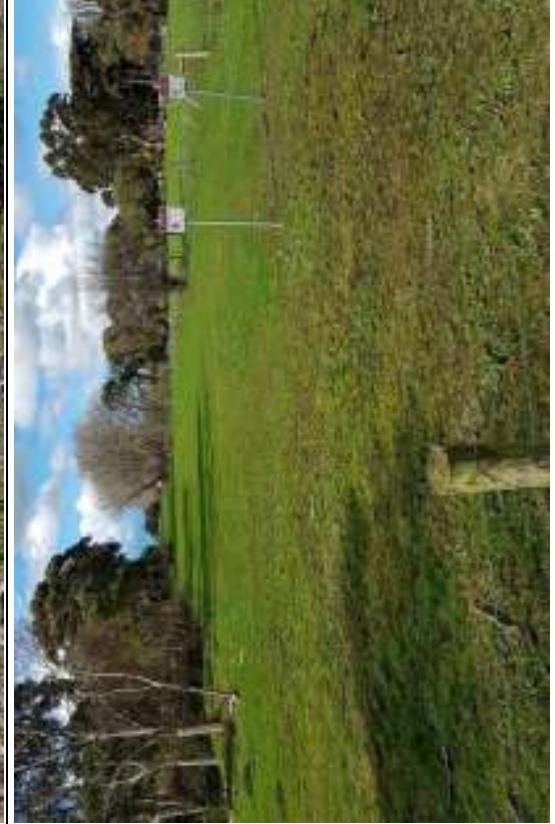
<p>Koo Wee Rup Bypass to Deep Creek Drain Complex (KP153.4 to KP156.05):</p> <p>The remaining tubestock patch at KP153.5 has ~90% survival of original planting. Grasses and rushes have undergone seasonal senescence and winter dormancy, but will increase coverage in spring.</p> <p>Some planted grasses remain at KP156, but majority is pasture. Elsewhere pasture well established.</p>	<p>Photo 2: Railway Rd. KP154.8, facing east. Grazed RoW.</p>

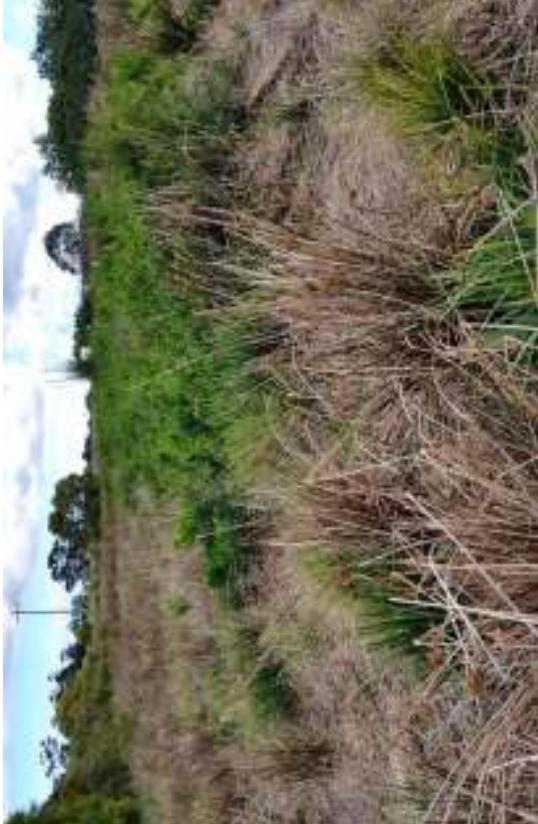
<p>Photo 4: Rail Reserve near Dalmore Rd. KP157.7. facing west.</p>

<p>Deep Creek Drain Complex to Dalmore Rd (Kp156.6 to KP158.03) – the largest revegetation area at this location. It has very good survival and growth of original planted stock, estimated to be ~95 % of the expected plant density.</p>
---------------------------------	--	---	--

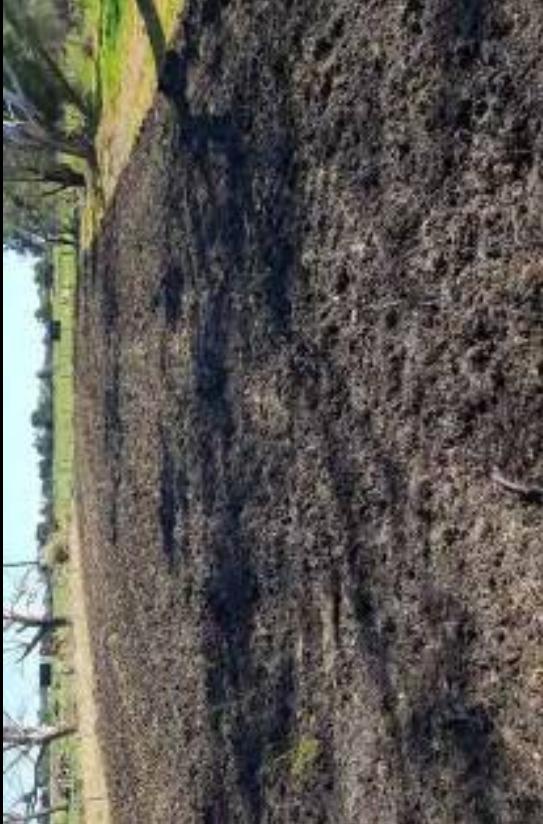
<p>Photo 3: Peers Rd, reveg area A, facing west.</p>

ESSO PIPELINE REPLACEMENT PROJECT		REVEGETATION RECORD	ESSO
MONITORING POST PLANTING			
Milestone: 12 months Target: 60% cover over 90% area Date: 14/09/2018	<p>The whole area has been recently worked to loosen the soil and replanted with tubestock, following low survival of the original planting. Plants have yet to establish any assessable cover.</p>

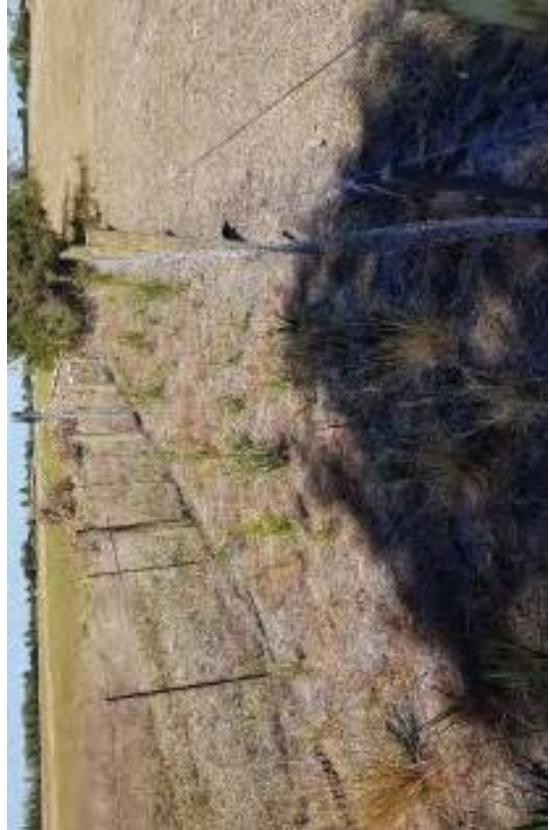
Photo 1: Peers Rd reveg area B, eastern windbreak, facing south	
Date: 08/03/2018		Good survival and growth. Estimated survival is 95 %.

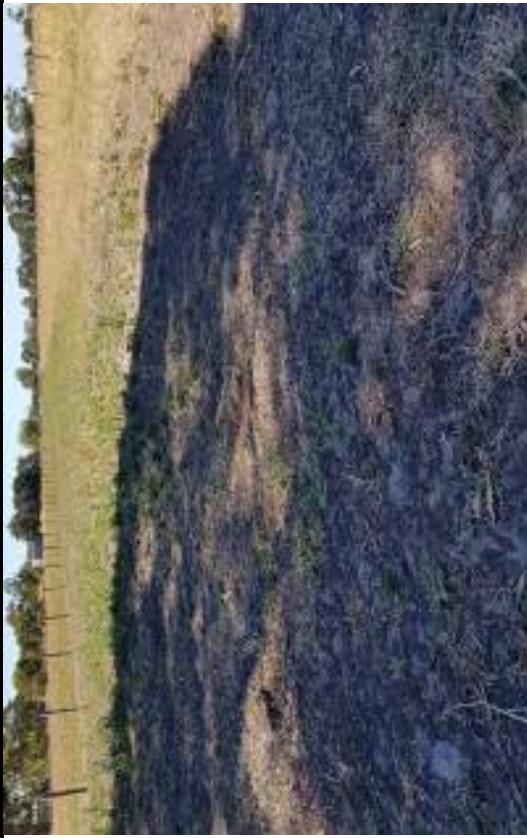
<p>Photo 1: Tooradin Station Road revegetation area (facing east)</p>

ESSO PIPELINE REPLACEMENT PROJECT	REVEGETATION RECORD	
MONITORING POST PLANTING		
<p>Milestone: 6 months Target: N/A- pasture only Date: 06/03/2018</p> <p>Pasture is currently in summer senescence, however there was minimal evidence of pasture having established prior to summer within the reinstated area, particularly in the area adjacent to the roadside row of large Eucalyptus. Ground conditions are very dry and the roadside vegetation appears to be causing a small localised rain shadow.</p> <p>Note: similar bare ground is present adjacent to roadside vegetation outside the reinstated RoW, suggesting this is more broad than just an issue with reinstatement.</p>

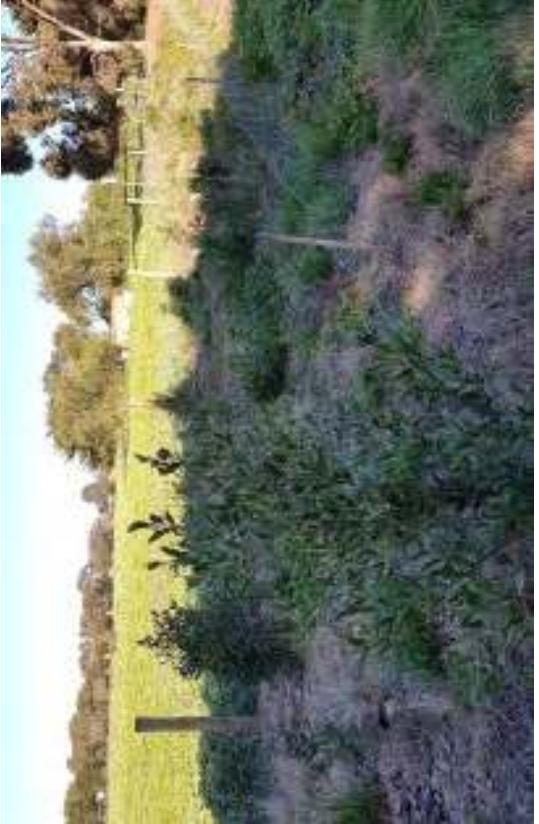
<p>Photo 4: Landale Rd, east side, facing south.</p>

ESSO PIPELINE REPLACEMENT PROJECT	REVEGETATION RECORD
<p>Milestone: 12 months Target: 60% cover over 90% area Date: 13/09/2018</p> <p>Survival on both roadsides is good, with significant growth observed. Cover is greater than 60% across the site.</p>

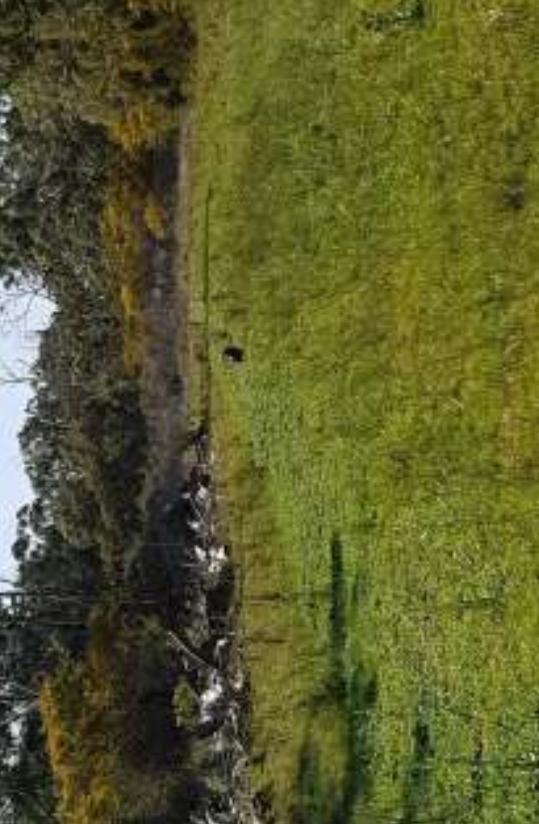
<p>Photo 6: BlueScope revegetation. KP180.</p> <p>Swamp wallaby browsing on reveg area.</p>
--	--	---

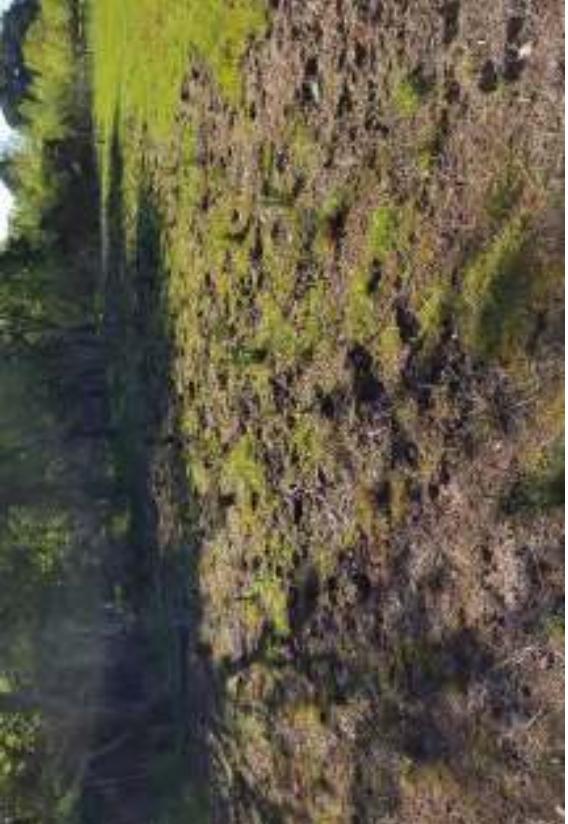
<p data-bbox="838 185 931 614">Photo 8: BlueScope revegetation. KP180.55, partial width of RoW Podding and grazing by cattle</p>

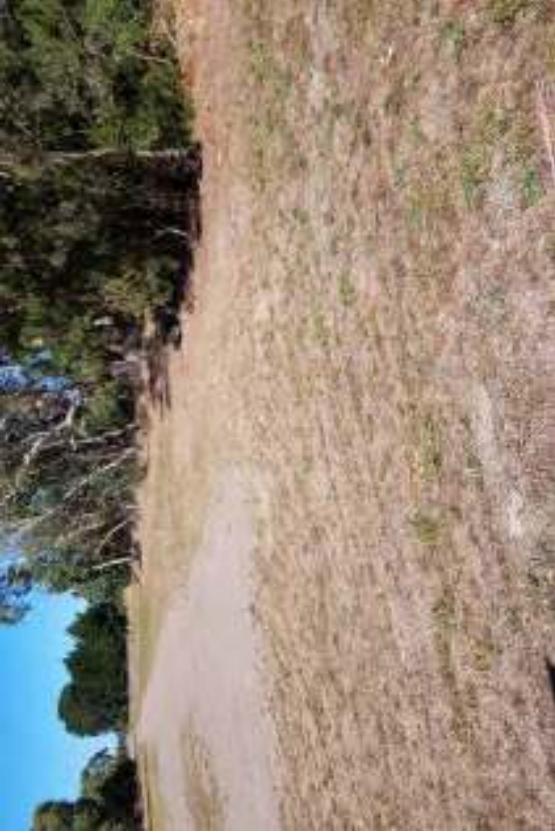
Photo 1: Thornells Rd revegetation area, facing south
Target: 80% survival			
Date: 09/03/2018			
<p>Recent subsidence repair has partially disturbed the revegetation area; however, the land owner had evidently already mowed the area.</p> <p>Estimated survival is <20%, with grasses in summer senescence, they are indistinguishable from pasture regrowth.</p>
