ESSO PIPELINE REPLACEMENT PROJECT	ANNUAL COMPLIANCE REPORT

ESSO PIPELINE REPLACEMENT PROJECT (EPBC 2014/7202)

ANNUAL COMPLIANCE REPORT # 3

EMEL-RPT-355-EN203

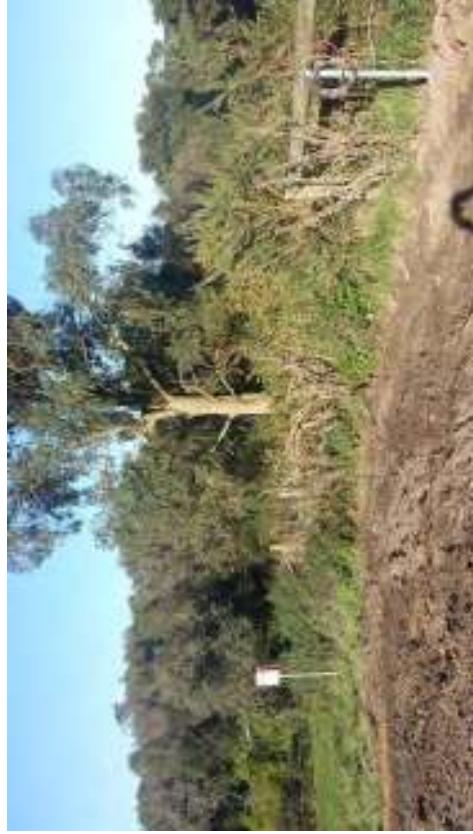
<p>Photo 1: Triangular area between fence and two poles represents undisturbed Southern Brown Bandicoot habitat. Photo looking west.</p>	
Notes	Limited construction disturbance to this area. Pasture reinstatement only. Figure 1.

ESSO PIPELINE REPLACEMENT PROJECT		REVEGETATION RECORD	ESSO
MONITORING POST PLANTING			
Milestone: 6 months Target: N/A – pasture only	Date: 08/03/2018	Area of undisturbed vegetation (primarily weed species) identified as SBB habitat remains, with additional growth. Pasture grasses established with ~100% coverage across reinstated RoW.

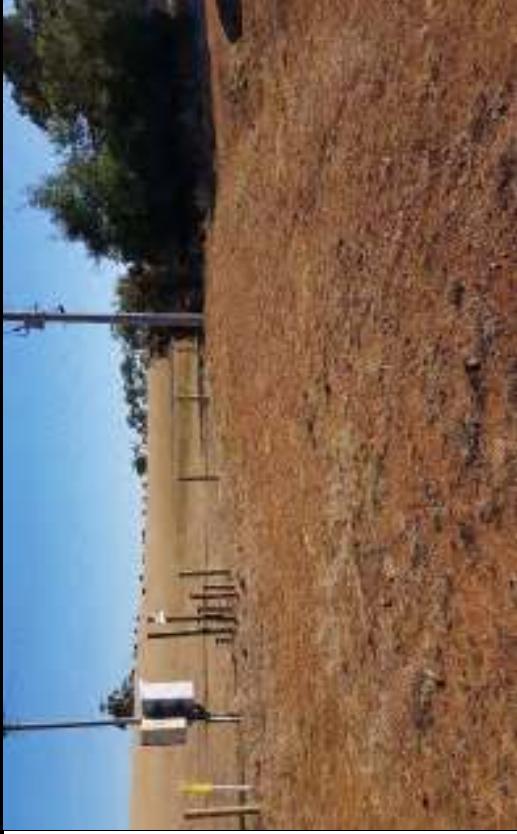
MONITORING POST PLANTING <p>Milestone: 6 months Target: 80% survival Date:</p> <p>The western roadside has been vehicles during the installation of new power poles since planting.</p> <p>This area is also very dry, with no reestablishment of grasses or weed species. On the western roadside, survival is <10 %.</p> <p>The eastern roadside is more shelter and is not impacted by vehicle traffic. Overall survival is high, with a 3 m x 3m patch over the installed pipe requiring replanting. Survival is estimated at 80 % -90 %, with a patch approximately 2 m x 3 m requiring replanting.</p>	<p>Photo 1: Westerport Road – western roadside (facing north)</p>

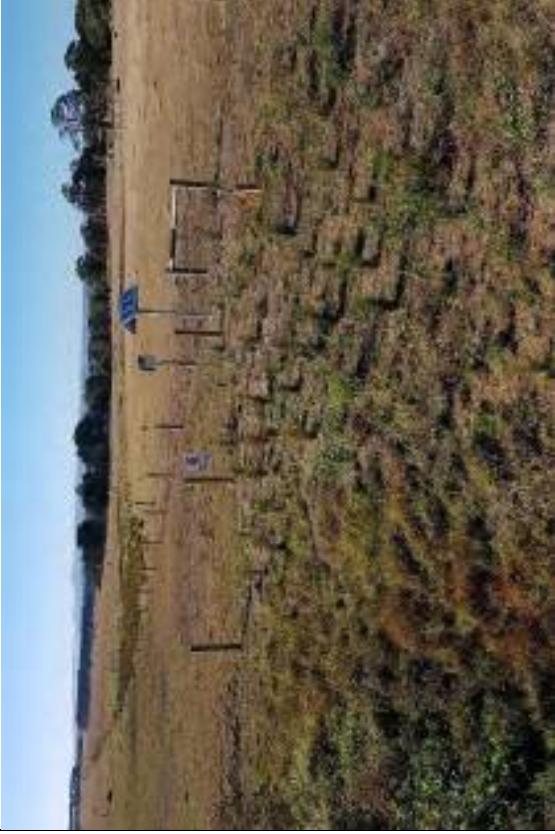
<p>Photo 2: Westerport Road – eastern roadside (facing east)</p>

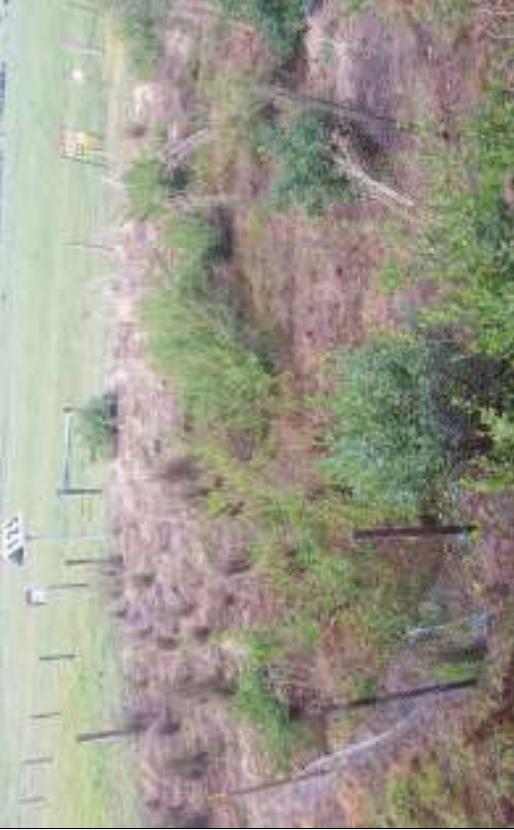
<p>The area on the western roadside 100% of expected plant density within the revegetation area. This is primarily 12-month-old replanting following low survival of the original planting. Cover remains low as plants are establishing, but is expected to increase significantly with spring growth.</p>

Photo 5: Westernport Road – western roadside (facing southeast)

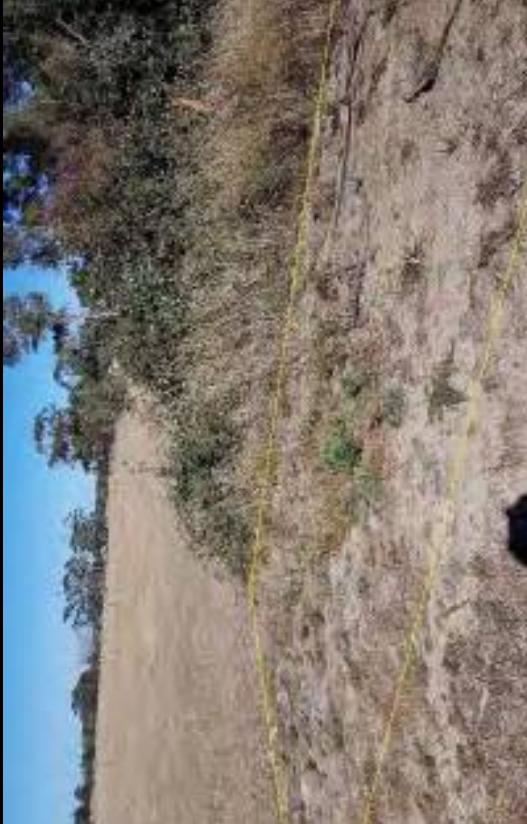
Milestone: 6 months Target: 80% survival Date: 06/03/2018	<p>Survival within the designated habitat area is estimated at 80%. Plants appear water stressed and have not grown significantly since planting.</p>

<p>Photo 1: Chambers Rd, south side, facing south west. Yellow shows approximate reveg area boundaries.</p>	<p>Milestone: 12 months Target: 60% cover over 90% area Date: 13/09/2018</p> <p>Survival remains at an estimated 80%. Little or no growth observed in grasses over winter. Some creepers beginning to establish. Cover assessed as less than 50%. Bare ground between plants a result of suppression of weeds and pasture grasses by weed control spraying.</p>

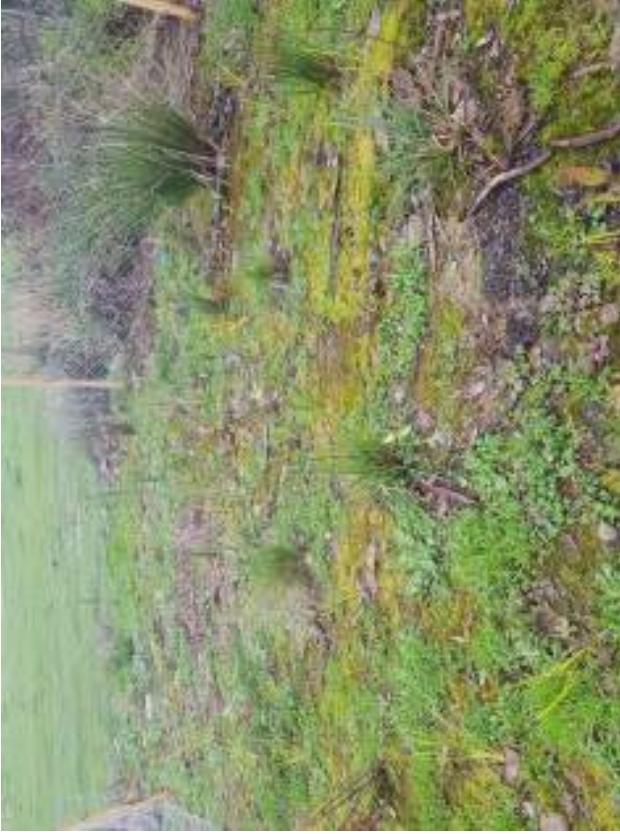
ESSO PIPELINE REPLACEMENT PROJECT	REVEGETATION RECORD
<p>Milestone: 2 years Target: 90% survival Date: 08/08/2019</p> <p>The survival of original plants remains at ~80%. With maintenance planting, this area has 100% of the expected plant density within the revegetation area.</p> <p>Cover remains low as plants are still establishing, but with rabbit protection now installed, this is expected to increase significantly over spring.</p>	<p>Photo 3: Chambers Rd, south side, facing south.</p>

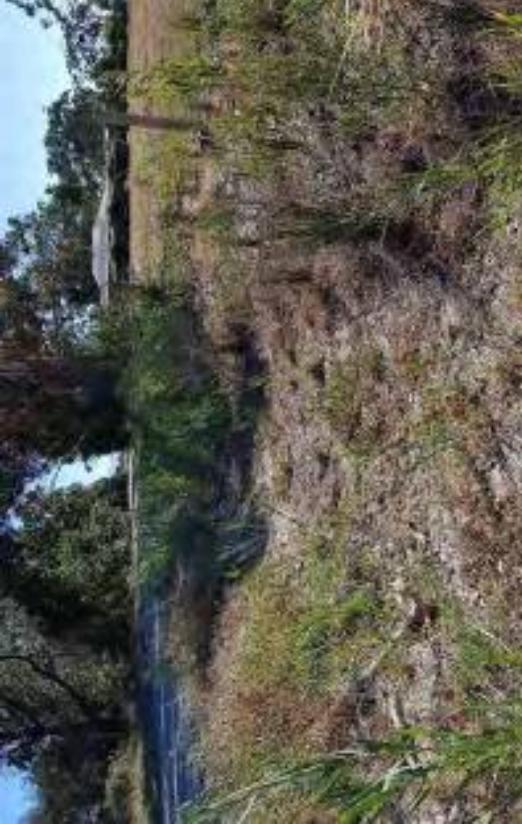
MONITORING POST PLANTING <p>Milestone: 6 months Target: 80% survival Date: 06/03/2018</p> <p>Good survival of planted stock, estimated at 95%, with additional reestablishment of native reeds (<i>Phragmites australis</i>) on the eastern roadside.</p>	<p>Photo 1: Bridge Road. Eastern side, facing north.</p>

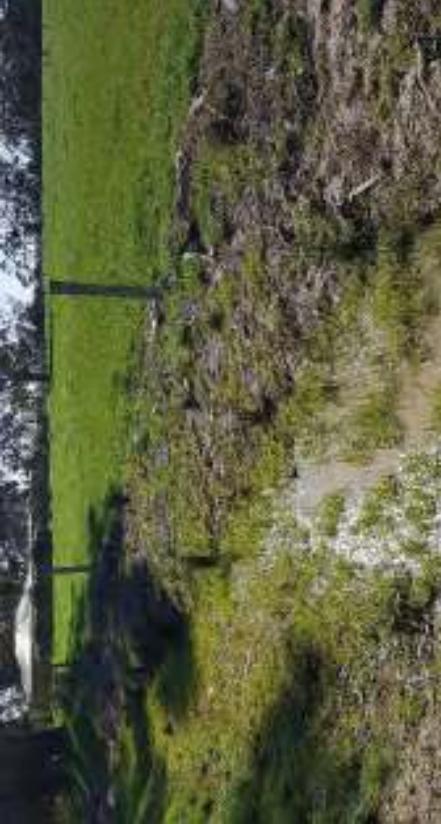
<p>MONITORING POST PLANTING</p> <p>Milestone: 12 months Target: 60% cover over 90% area Date: 13/09/2018</p> <p>Survival on the eastern roadside has decreased, estimated at 66%-75% and phragmites has seasonally died back. Little growth of planted tubestock. Cover less than 50%.</p> <p>Survival on the western roadside is high (~95%) and substantial growth observed. Cover >75%.</p>	<p>Photo 3: Bridge Road. Eastern side, facing north.</p>

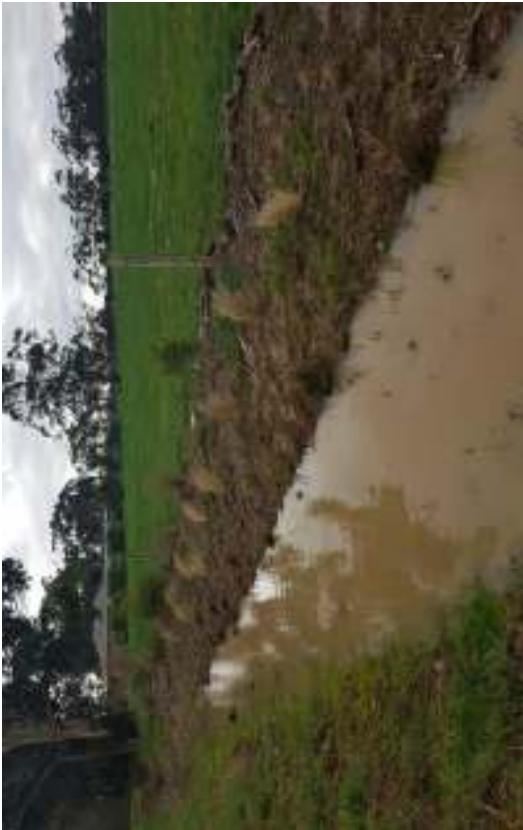
<p>Photo 5: Bridge Road. Eastern side, facing north.</p>

ESSO PIPELINE REPLACEMENT PROJECT	REVEGETATION RECORD	
MONITORING POST PLANTING		
Milestone: 2 years Target: 90% survival Date: 08/08/2019	<p>Survival on both roadsides is good and with maintenance planting, this area has ~95% of the expected plant density within the revegetation area.</p> <p>Phragmites in the drain has seasonally died back.</p> <p>Grasses and rushes on the edge of the drain appear to have been slashed, most likely during council vegetation maintenance work on the drain.</p> <p>Grasses and rushes have undergone seasonal senescence and winter dormancy, but will increase coverage in spring.</p>

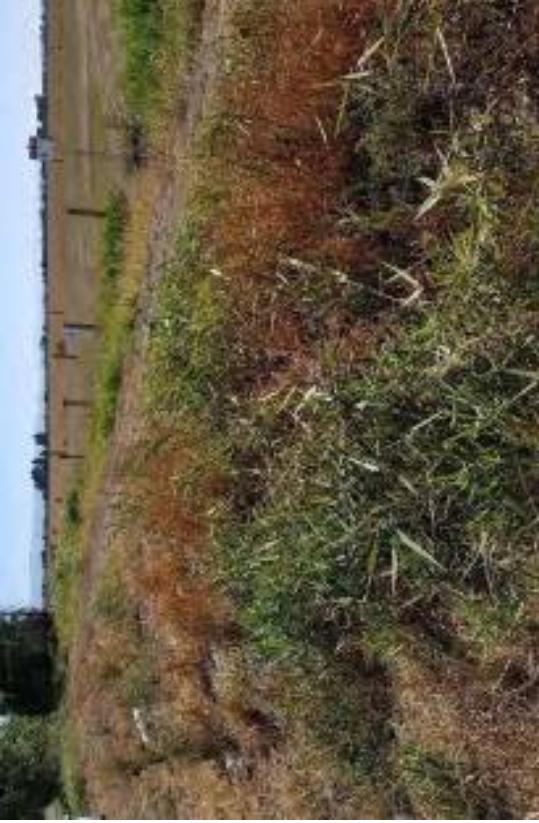
MONITORING POST PLANTING Milestone: 6 months Target: 80% survival Date: 06/03/2018	<p>Photo 1: Caldermeade Road. Eastern side, facing north. Shows slashed access track.</p>

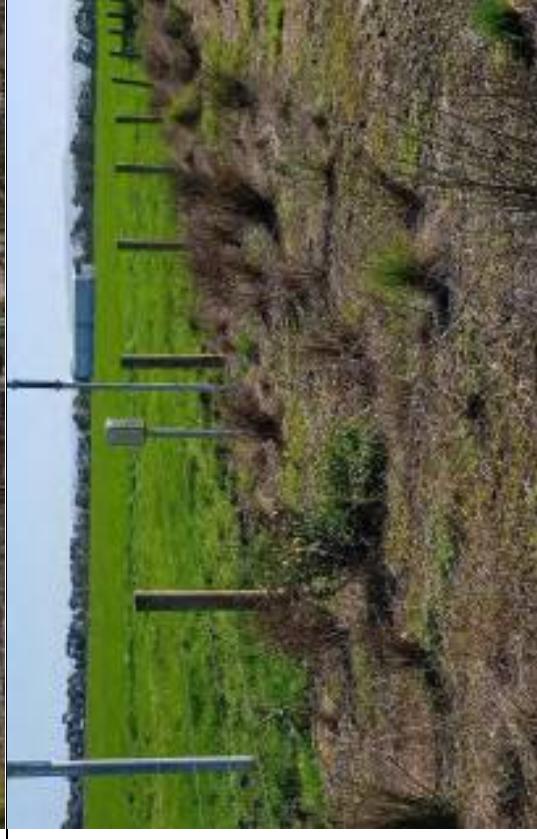
<p>Photo 4: Caldermeade Road. Western side, facing north.</p>

ESSO PIPELINE REPLACEMENT PROJECT	REVEGETATION RECORD	ESSO
<p>MONITORING POST PLANTING</p> <p>Milestone: 12 months Target: 60% cover over 90% area Date: 13/09/2018</p> <p>Survival on the eastern roadside is low (~50%) there has been little growth and phragmites has died back. Some supplementary planting is evident but has not yet established any assessable cover. Cover is less than 50%.</p> <p>Survival on the western roadside is ~80% and there has been moderate growth of plants. Cover is ~60%.</p>

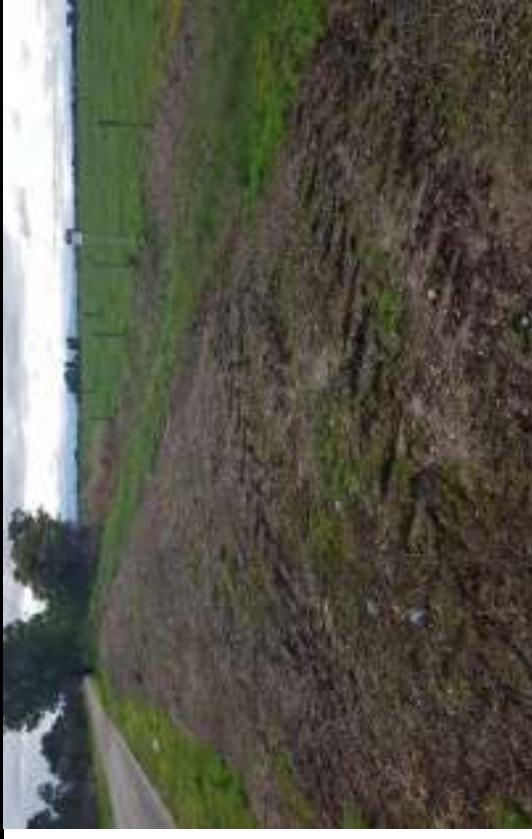
Milestone: 2 years Target: 90% survival Date: 08/08/2019	<p>Survival of the original and supplementary planting on the eastern roadside is ~0%. Further replanting is required.</p> <p>With maintenance planting, the western roadside has 100% of the expected plant density within the revegetation area.</p> <p>Cover remains low as plants are still establishing, but with rabbit protection now installed, this is expected to increase significantly over spring.</p>	<p>Photo 5: Caldermeade Road. Eastern side, facing north.</p>

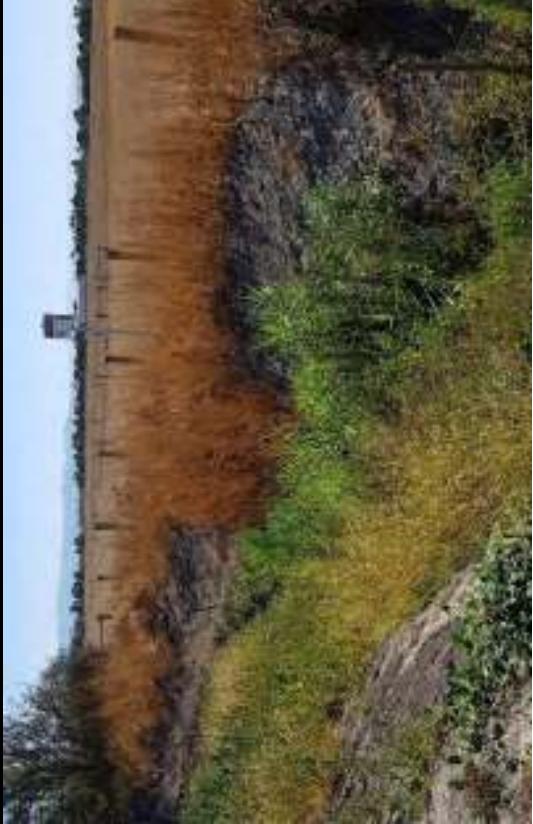
Milestone: 6 months Target: 80% survival Date: 06/03/2018	<p>Fencing intact and appears effective in excluding rabbits (no diggings within fenced area, lots adjacent).</p> <p>Estimated survival of planted stock on the eastern bank is very low, at ~ 10%, with only scattered individual plants present between dead weeds.</p>

<p>Photo 1: Malcolm's Rd extension drain, looking north across to the eastern bank.</p>

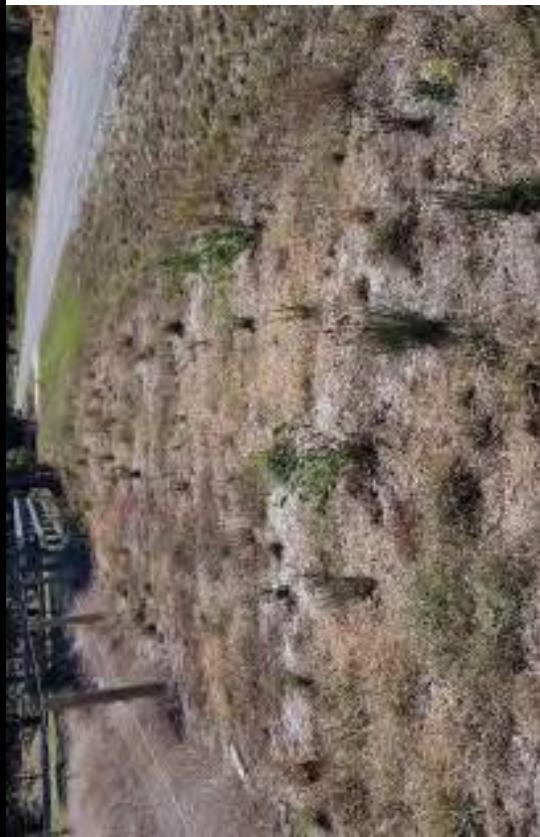
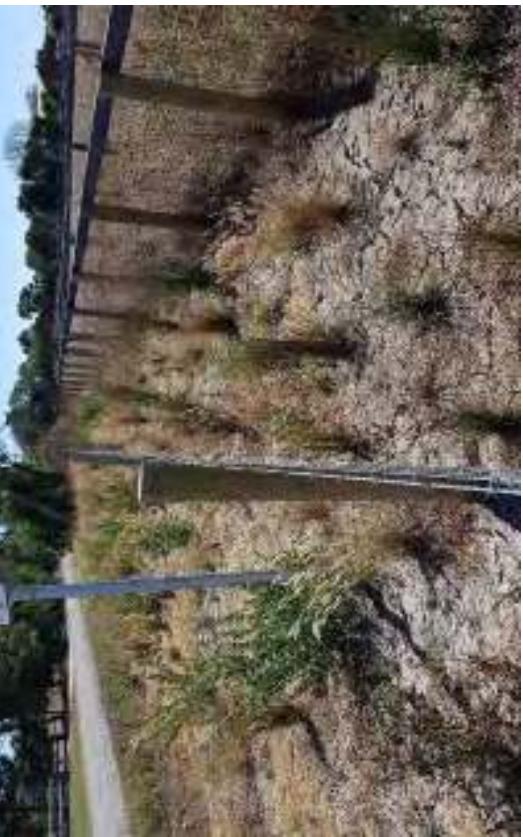
**Photo 1:**

Survival is very good on the eastern roadside, and acceptable on the western roadside. Less growth is also apparent on western side.

Overall estimated survival is 95%.

O'Briens Rd. Western side, facing north.

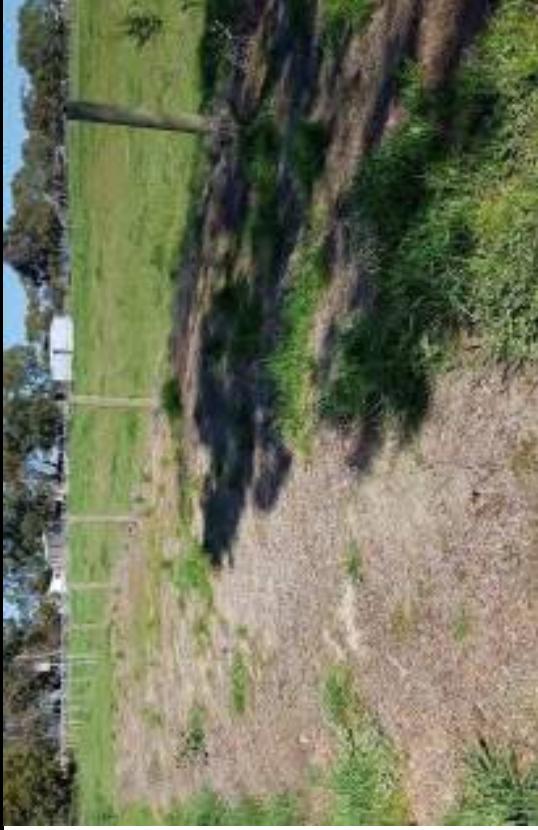
<p>MONITORING POST PLANTING</p> <p>Milestone: 12 months Target: 60% cover over 90% area Date: 13/09/2018</p> <p>Survival of the original planting is now low on the western roadside, the area has been recently replanted, but this has not yet established any assessable cover. Survival is good on the eastern roadside, although there has been only modest growth. Cover is less than 50% across the site.</p>	<p>Photo 3: O'Briens Rd. Western side, facing south.</p>

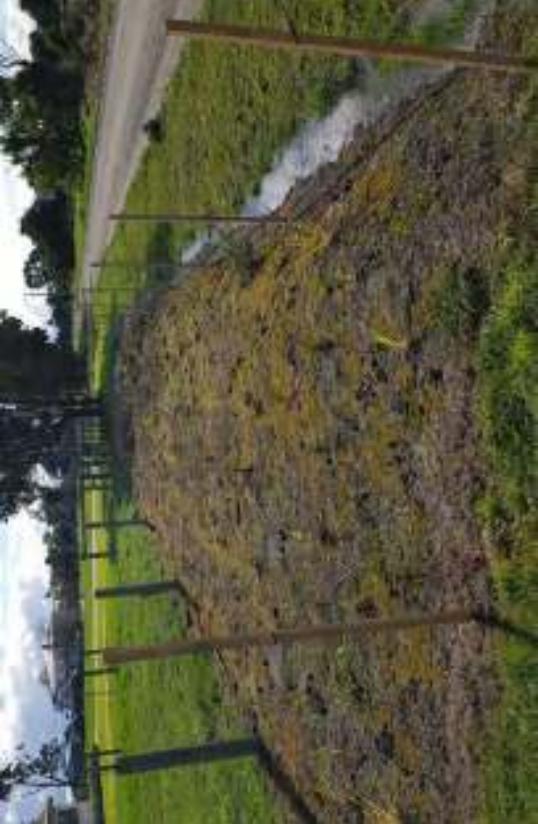
<p>MONITORING POST PLANTING</p> <p>Milestone: 2 years Target: 90% survival Date: 08/08/2019</p> <p>The area on the western roadside has been recently replanted with tube stock, following low survival of the earlier plantings. The density of plants is 100% of expected density, however they have yet to establish any assessable cover.</p> <p>The eastern roadside has >90% of the expected plant density within the revegetation area.</p>	<p>Photo 5: O'Briens Rd. Western side, facing north.</p>

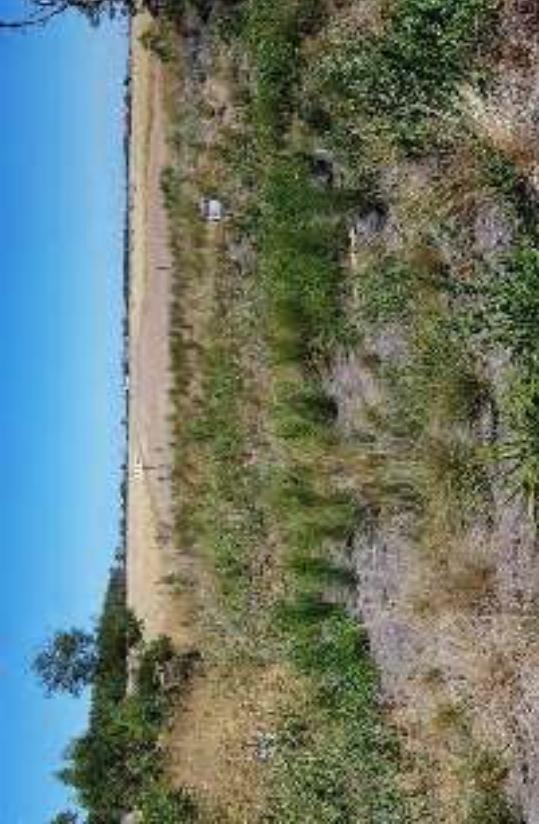
<p>Photo 1: South Gippsland Rail Reserve crossing, facing southwest.</p>

<p>MONITORING POST PLANTING</p> <p>Milestone: 6 months Target: 80% survival</p> <p>Date:</p> <p>High survival and strong growth across the site. Additional reestablishment of native reeds (<i>Phragmites australis</i>) in low areas. Estimated survival is 95%.</p>

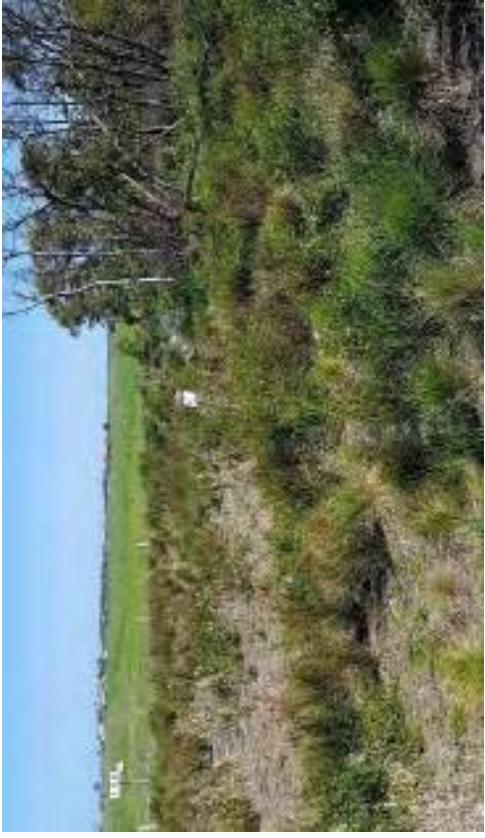
<p>Photo 3: South Gippsland Rail Reserve crossing, facing southwest.</p>

ESSO PIPELINE REPLACEMENT PROJECT	REVEGETATION RECORD	
MONITORING POST PLANTING		
Milestone: 12 months Target: 60% cover over 90% area Date: 13/09/2018	<p>Survival remains very high and, although there has been little growth over winter and the phragmites has died back (seasonal), cover is estimated to be ~70-80% across the site.</p>

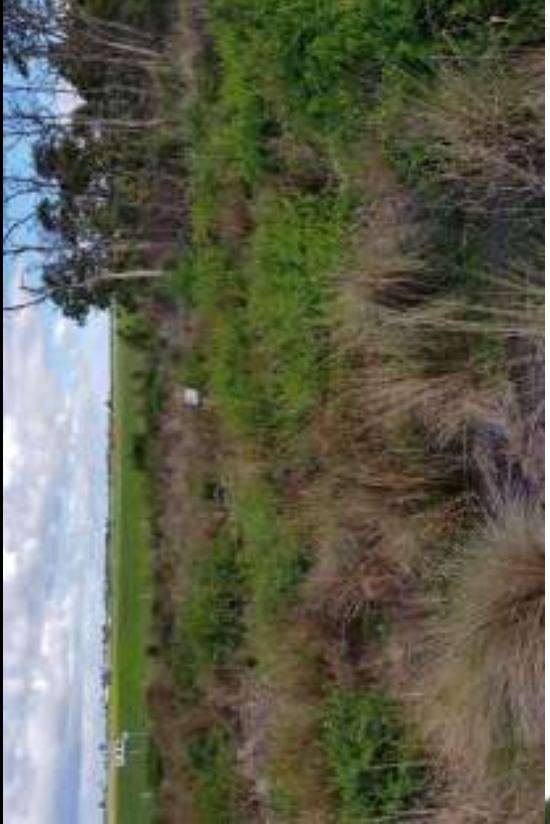
<p>MONITORING POST PLANTING</p> <p>Milestone: 2 years Target: 90% survival Date: 08/08/2019</p> <p>Survival is very high, with close to 100% of the expected plant density within the revegetation area. Plants are well established and provide 95-100% cover.</p>	<p>Photo 5: South Gippsland Rail Reserve crossing, facing southwest.</p>

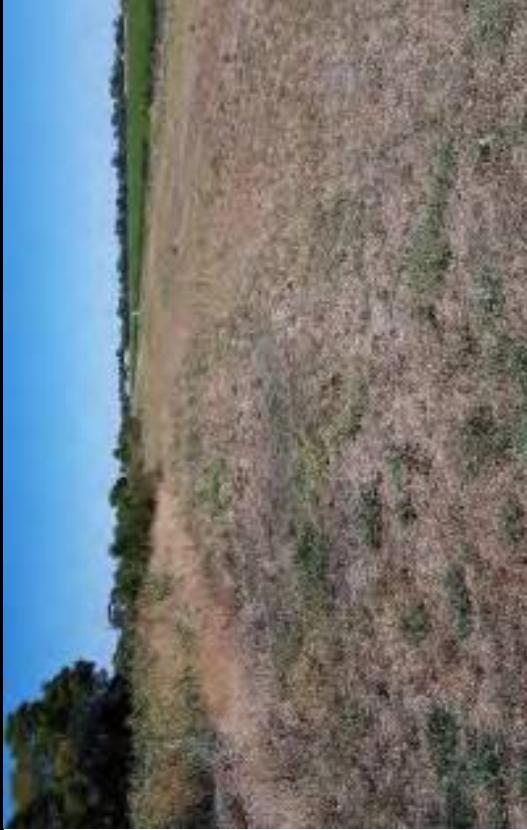
<p>ESSO PIPELINE REPLACEMENT PROJECT</p>	<p>REVEGETATION RECORD</p>	<p>MONITORING POST PLANTING</p>
		<p>Photo 3: Railway Rd. KP156, facing east. Mowed RoW.</p>

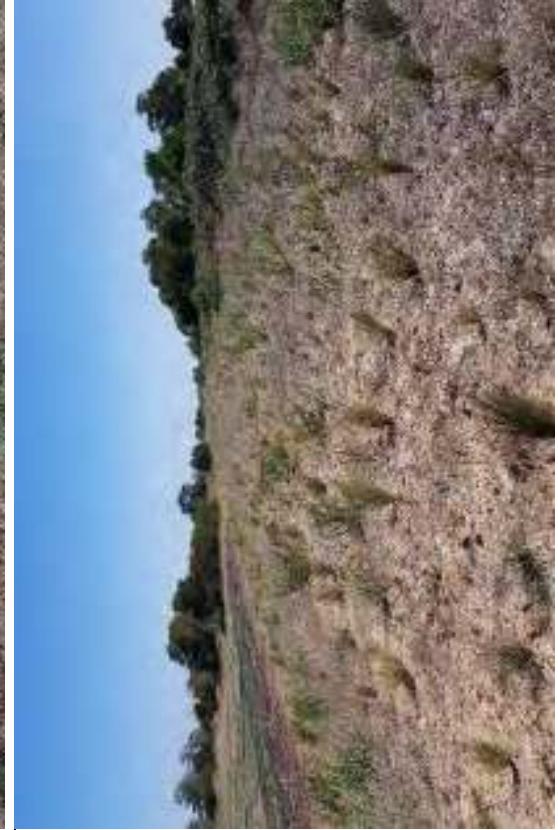
<p>Photo 4: Rail Reserve near Dalmore Rd. KP157.7, facing west. Successful replanting.</p>

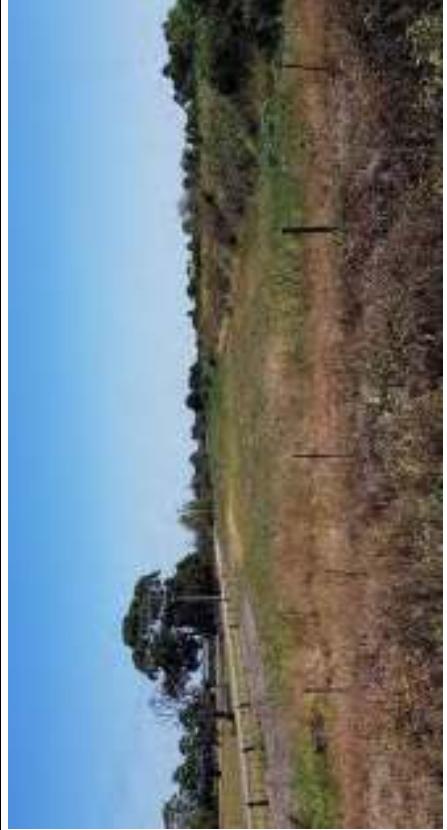
<p>Photo 5: Rail Reserve adjacent to Peers Rd. KP158, facing west. Cover crop to be resown with lucerne.</p>

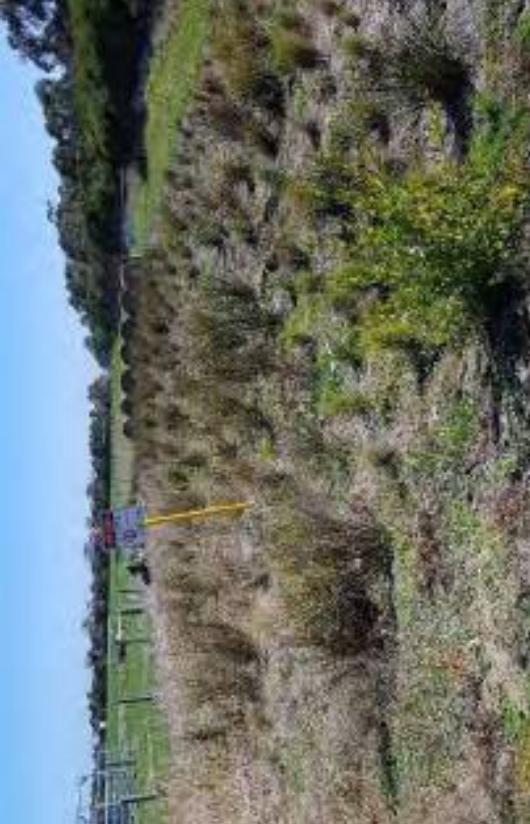
<p>Photo 1: Railway Rd. KP153.5, facing west.</p>

<p>MONITORING POST PLANTING</p> <p>Milestone: 12 months Target: 60% cover over 90% area</p> <p>Date: 13/09/2018</p> <p>Overall cover is assessed as greater than 60% cover over 90% area.</p> <p>Koo Wee Rup Bypass to Deep Creek Drain Complex (KP153.4 to KP156.05) – remaining tubestock patch at KP153.5 – good survival and growth, cover greater than 60%. Some planted grasses remain at KP156, but majority is pasture. Elsewhere pasture well established.</p>

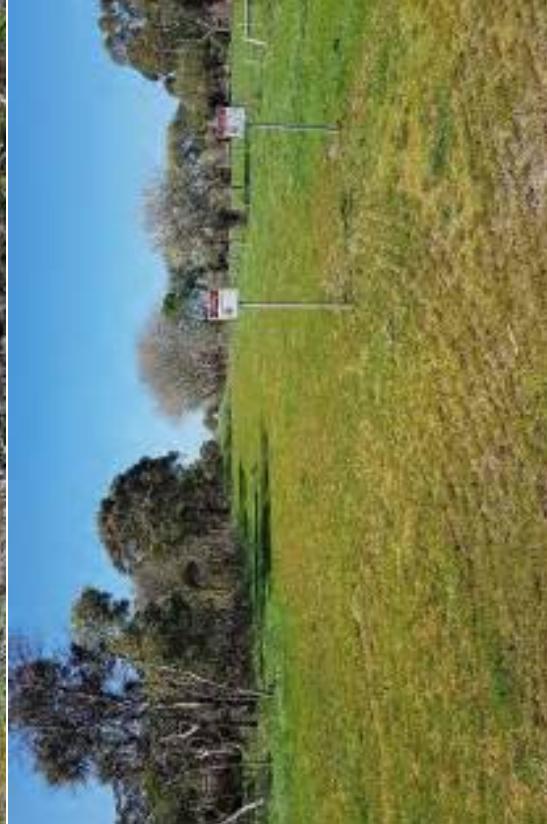
Photo 2:
Railway Rd. KP154.8, facing east. Grazed RoW.

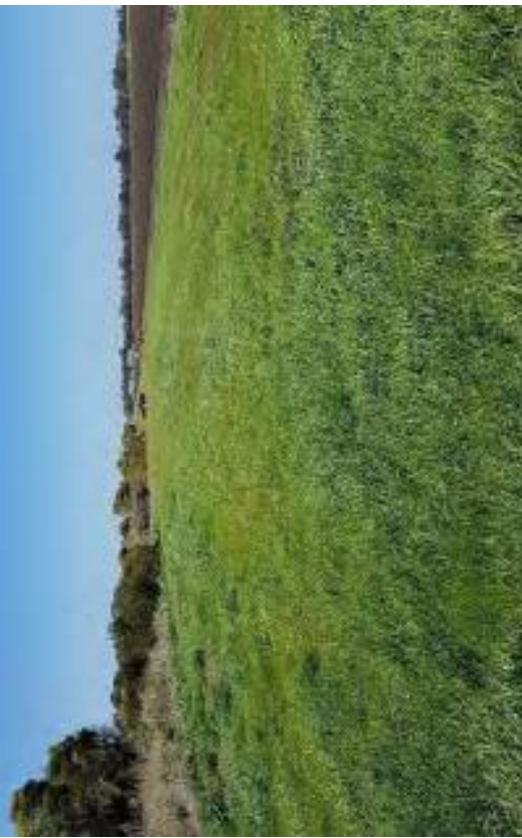
<p>ESSO PIPELINE REPLACEMENT PROJECT</p>	<p>REVEGETATION RECORD</p>	<p>MONITORING POST PLANTING</p>
		<p>Photo 3: Railway Rd. KP156, facing east. Mowed RoW. Some planted native grasses remain, but majority is pasture</p>

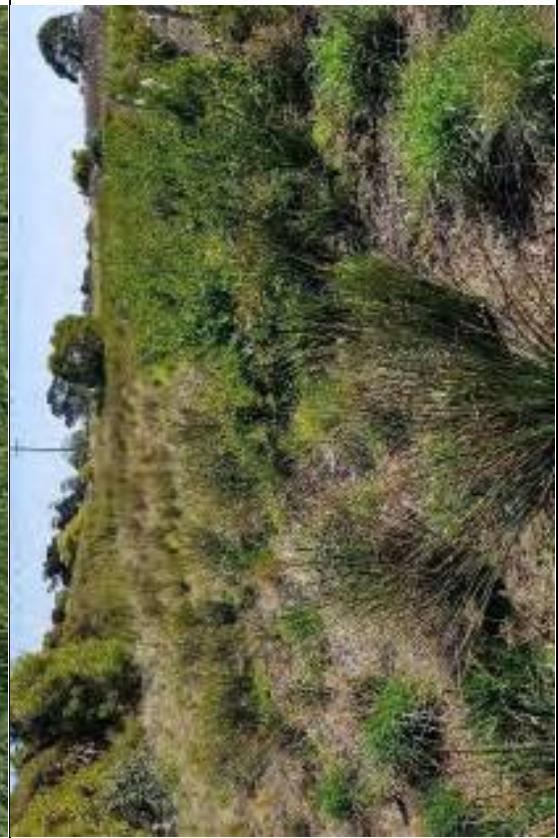
<p>Photo 4: Rail Reserve near Dalmore Rd. KP157.7. facing west.</p>

<p>Deep Creek Drain Complex to Dalmore Rd (Kp156.6 to KP158.03) – very good survival and growth of planted stock, cover greater than 60%.</p>

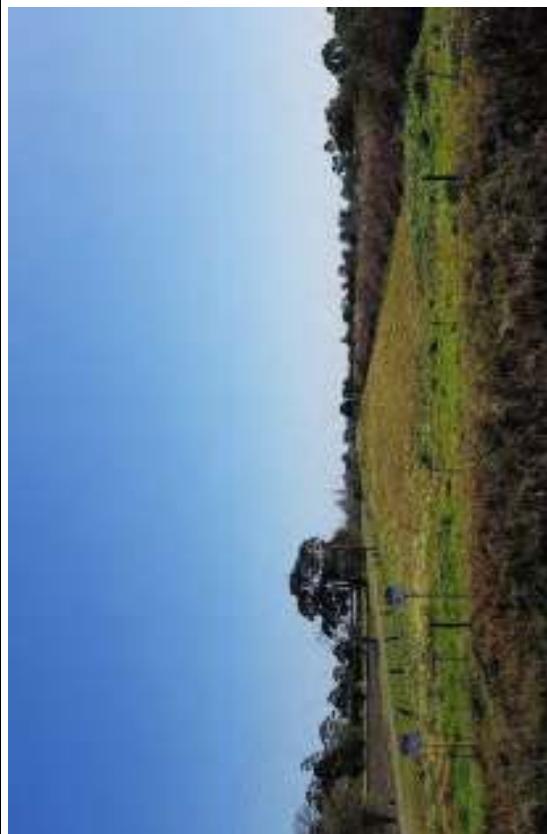
<p>Photo 5: Rail Reserve adjacent to Peers Rd. KP158, facing west.</p>

MONITORING POST PLANTING	<p>Dalmore Rd to Peers Rd (KP158.03 to KP159.1) – cover crop remains, land ~ fallow.</p>
---------------------------------	--

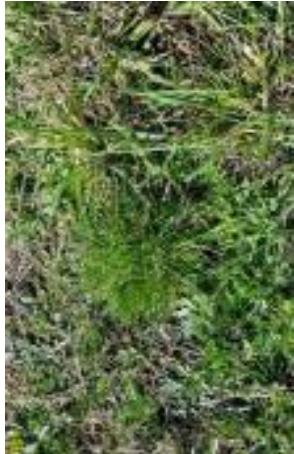
ESSO PIPELINE REPLACEMENT PROJECT	REVEGETATION RECORD
MONITORING POST PLANTING	<p>Photo 3: Railway Rd. KP156, facing east. Mowed RoW. Some planted native grasses remain, but majority is pasture, but they are difficult to distinguish from the pasture (see below).</p>

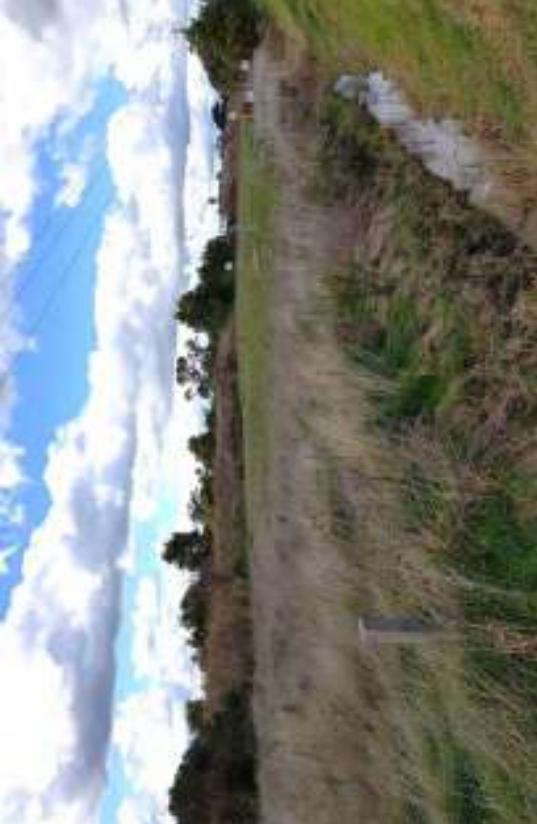
Photo 5: Rail Reserve adjacent to Peers Rd. KP159, facing east.
Dalmore Rd to Peers Rd (KP158.03 to KP159.1) – land occupier to resow crops, currently fallow.

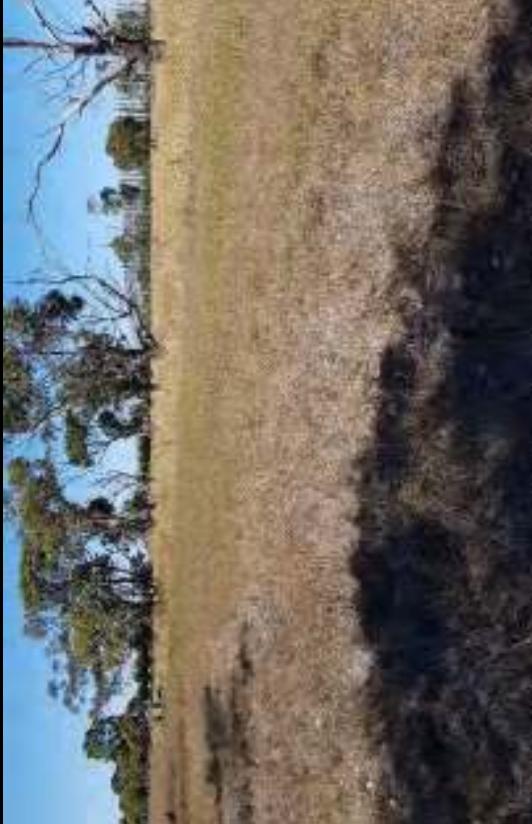
ESSO PIPELINE REPLACEMENT PROJECT	REVEGETATION RECORD	
MONITORING POST PLANTING	<p>Photo 1: Peers Rd, reveg area A, facing southeast.</p>

<p>Milestone: 6 months Target: 80% survival Date: 08/03/2018</p> <p>Grasses established across the site. No apparent survival of shrubs or small tree species. Individual native grasses difficult to distinguish from pasture. Estimated survival is <20 %.</p> <p>Soils are damper than surrounding areas. Rabbits are present in the area, but the revegetation area is fenced effectively. The landowner has excluded stock up to the time of the inspection and not mowed or otherwise disturbed the area.</p>

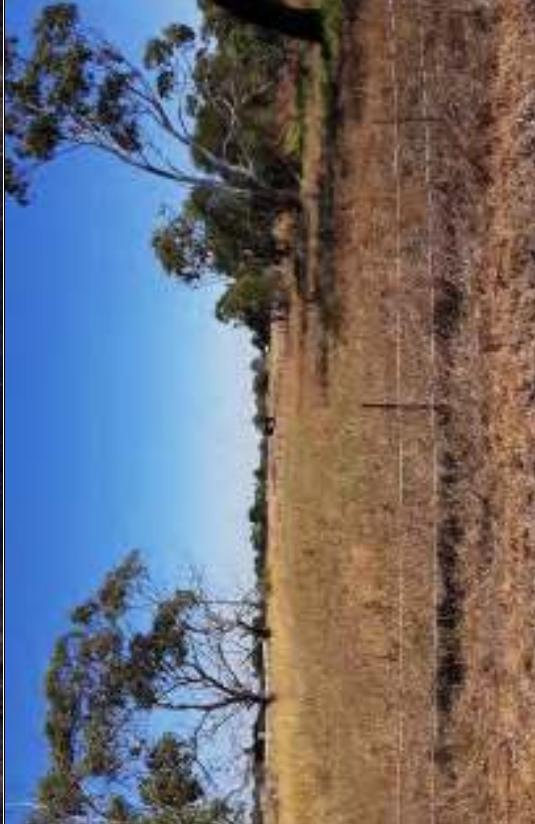
<p>Photo 2: Peers Rd, reveg area A, facing west.</p>

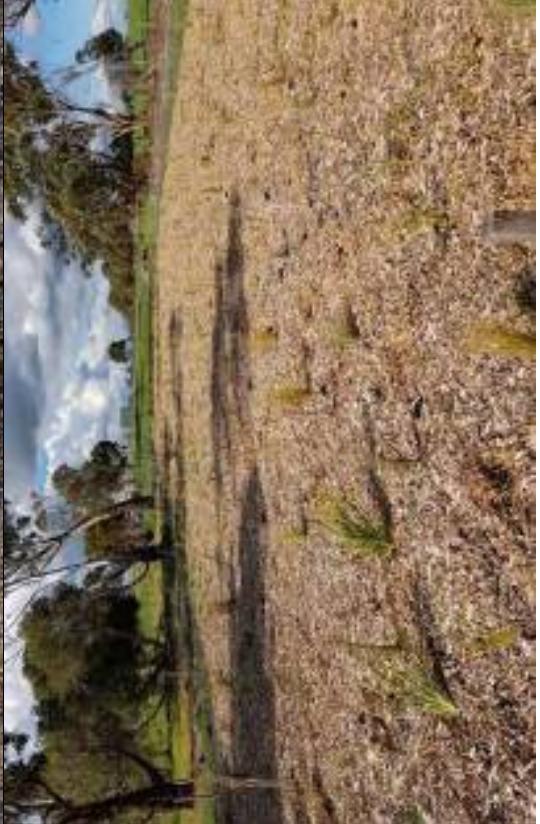
ESSO PIPELINE REPLACEMENT PROJECT		REVEGETATION RECORD	ESSO
MONITORING POST PLANTING			
Milestone: 12 months Target: 60% cover over 90% area Date: 14/09/2018	<p>The whole area has been recently worked to loosen the soil and replanted with tubestock, following low survival of the original planting. Plants have yet to establish any assessable cover.</p>

<p>Photo 3: Peers Rd, reveg area A, facing west.</p>

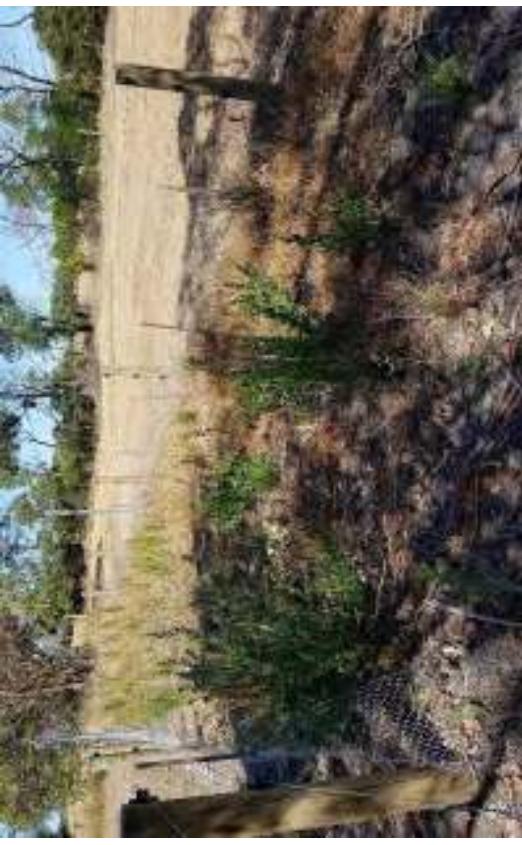
MONITORING POST PLANTING	<p>Photo 2: Peers Rd reveg area B, middle windbreak, facing south</p>

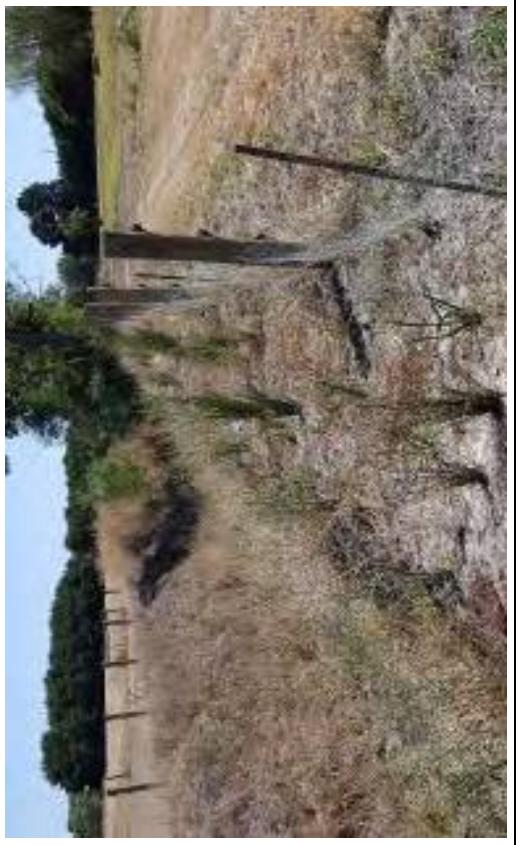
<p>Photo 3: Peers Rd reveg area B, western windbreak, facing north.</p>

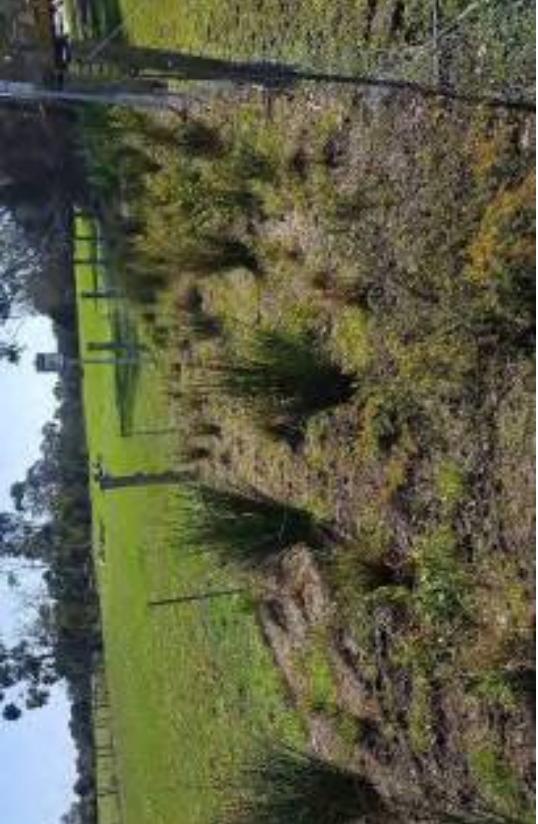
MONITORING POST PLANTING <p>Milestone: 12 months Target: 60% cover over 90% area Date: 14/09/2018</p> <p>Survival and growth are high on the eastern and middle windbreaks, which both have more than 60% cover.</p> <p>Survival is good, but growth lower on the western windbreak, which has an estimated 50% cover.</p>	<p>Photo 4: Peers Rd reveg area B, eastern windbreak, facing north</p>

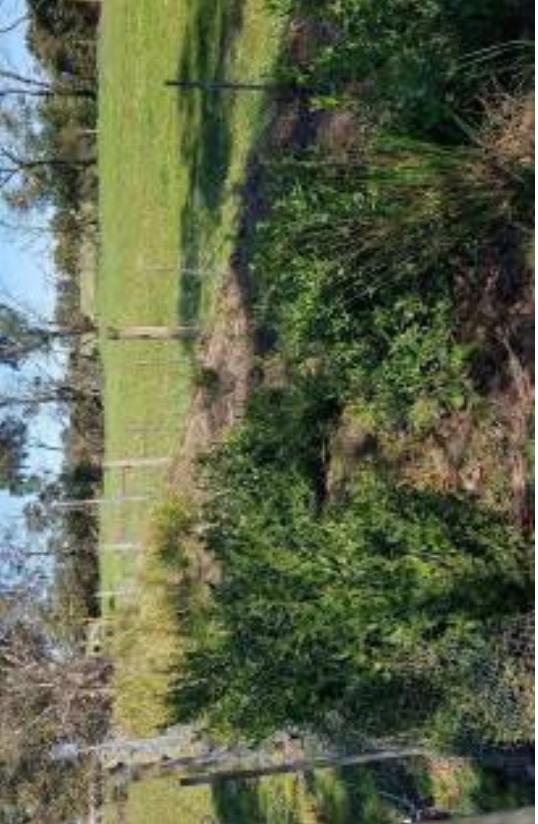
<p>Photo 5: Peers Rd reveg area B, middle windbreak, facing south</p>

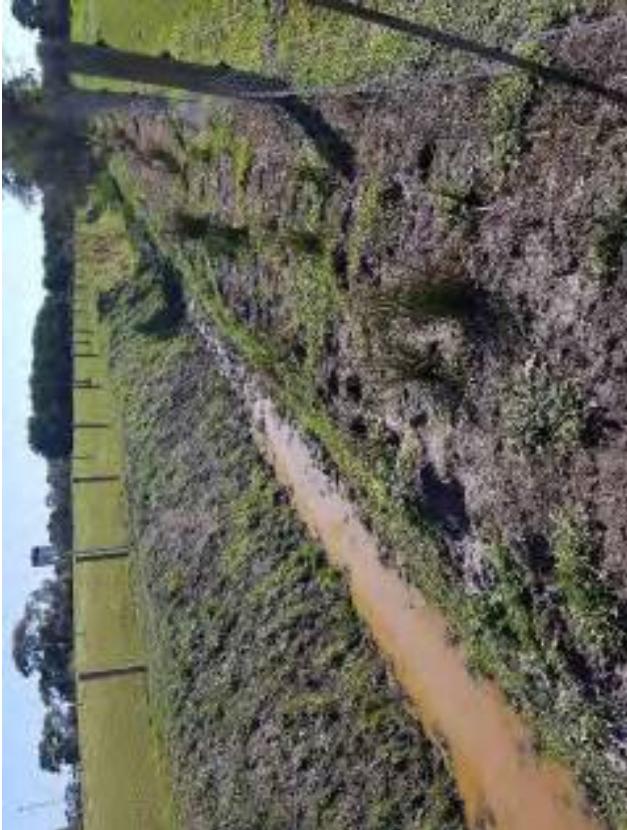
<p>Photo 6: Peers Rd reveg area B, western windbreak, facing north.</p>

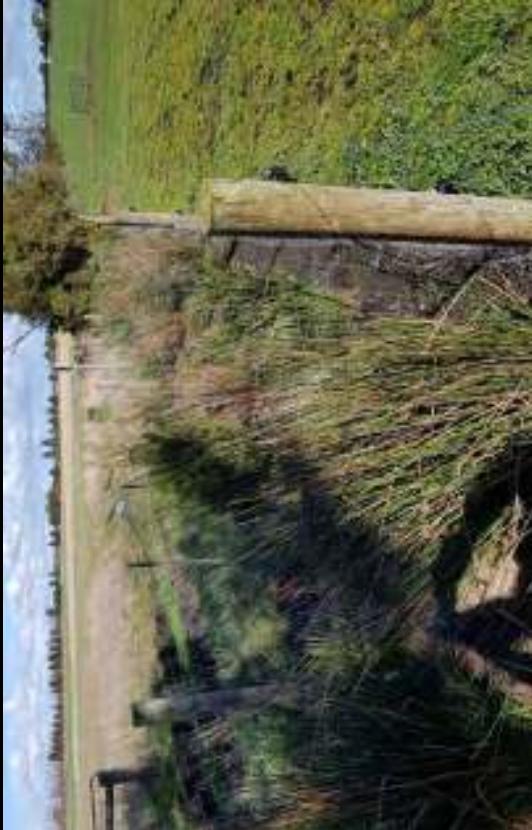
ESSO PIPELINE REPLACEMENT PROJECT	REVEGETATION RECORD	
MONITORING POST PLANTING		
<p>Milestone: 2 years Target: 90% survival Date: 08/08/2019</p> <p>Overall, this site has >90% of the expected plant density.</p> <p>Survival and growth are high on the eastern and middle windbreaks.</p> <p>Survival is good, but growth lower on the western windbreak, which has an estimated 50% cover. With maintenance planting, this area has ~85% of the expected plant density within the revegetation area.</p>

<p>Photo 7: Peers Rd reveg area B, eastern windbreak, facing north</p>

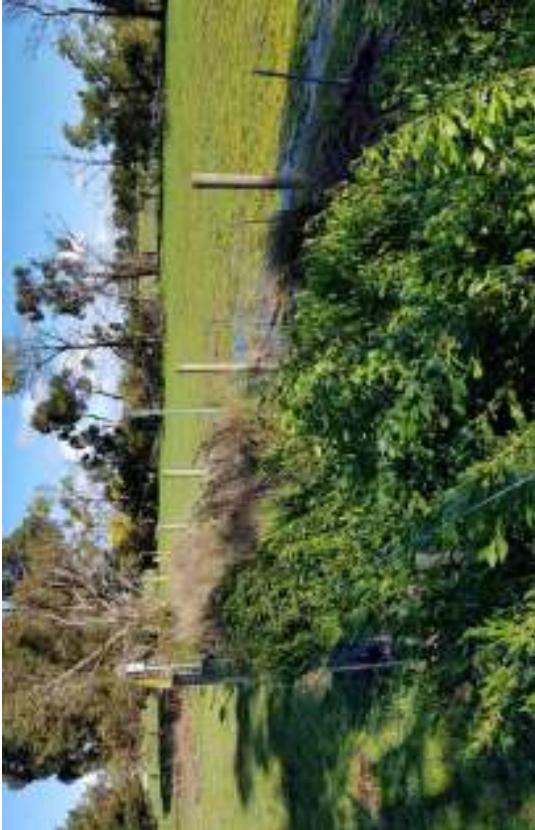
<p>Photo 8: Peers Rd reveg area B, middle windbreak, facing south</p>

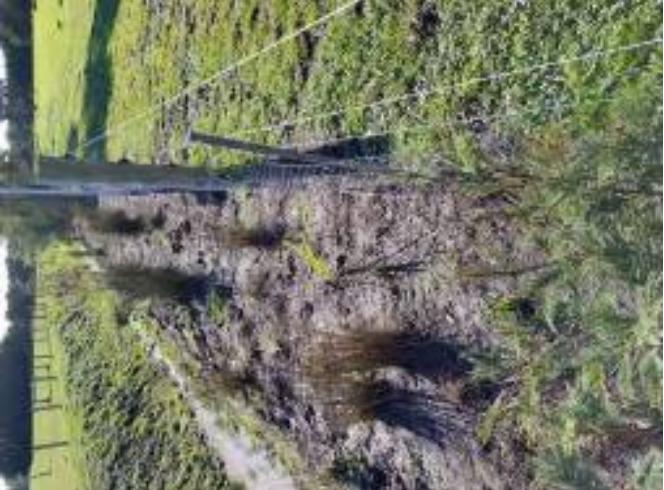
MONITORING POST PLANTING	<p>Photo 9: Peers Rd reveg area B, western windbreak, facing north.</p>

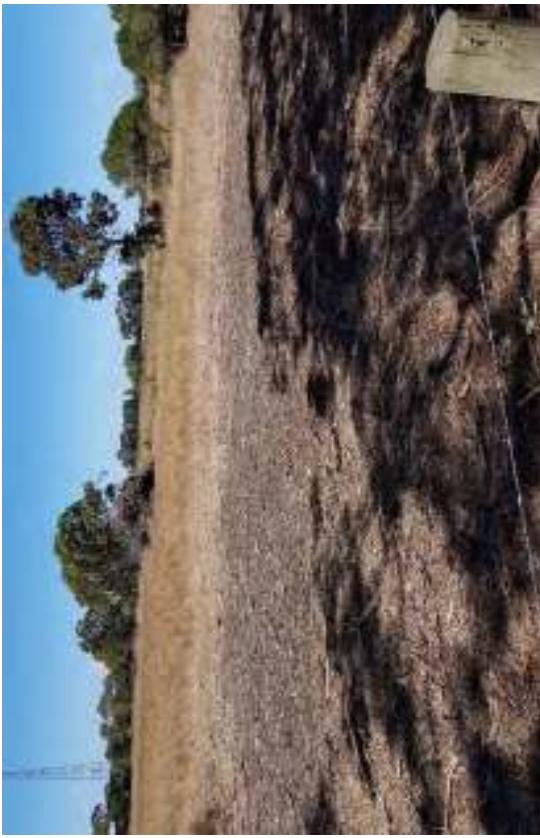
ESSO PIPELINE REPLACEMENT PROJECT	REVEGETATION RECORD	
MONITORING POST PLANTING		
<p>Milestone: 6 months Target: N/A- pasture only Date: 06/03/2018</p> <p>Pasture is currently in summer senescence, however there was minimal evidence of pasture having established prior to summer within the reinstated area, particularly in the area adjacent to the roadside row of large Eucalyptus. Ground conditions are very dry and the roadside vegetation appears to be causing a small localised rain shadow.</p> <p>Note: similar bare ground is present adjacent to roadside vegetation outside the reinstated RoW, suggesting this is more broad than just an issue with reinstatement.</p>

<p>Photo 2: Tooradin Station Road <u>outside</u> RoW (facing east)</p>

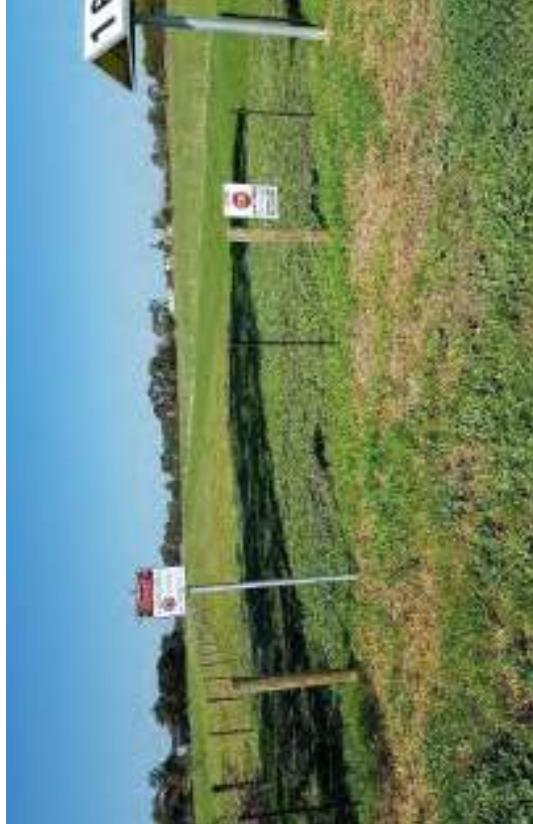
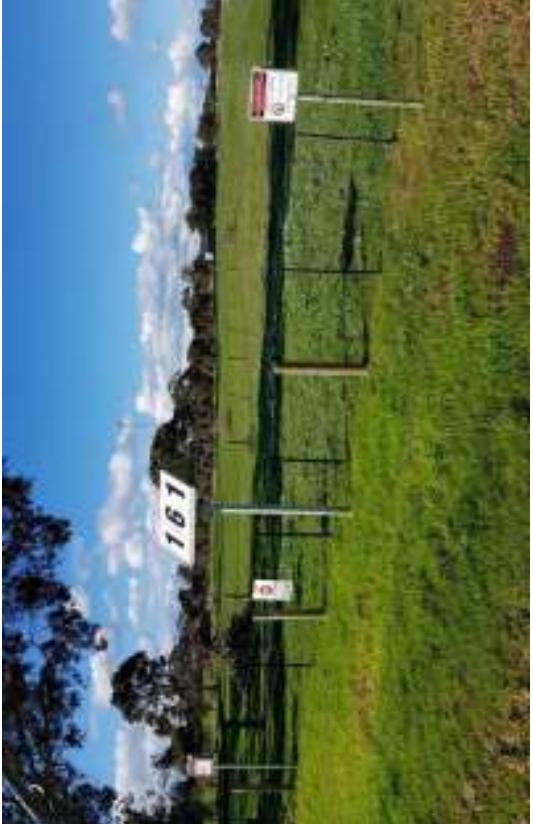
ESSO PIPELINE REPLACEMENT PROJECT	REVEGETATION RECORD	
ESSO	Photo 3: Tooradin Station Road revegetation area (facing east)	Photo 4: Tooradin Station Road revegetation area (facing north east)
MONITORING POST PLANTING <p>Milestone: 12 months Target: 60% cover over 90% area Date: 13/09/2018</p> <p>Pasture has established across the disturbed construction right of way, although interspersed with capeweed. Overall cover is greater than 60%.</p>
