ESSO PIPELINE REPLACEMENT PROJECT	ANNUAL COMPLIANCE REPORT

ESSO PIPELINE REPLACEMENT PROJECT (EPBC 2014/7202)

ANNUAL COMPLIANCE REPORT # 3

EMEL-RPT-355-EN203

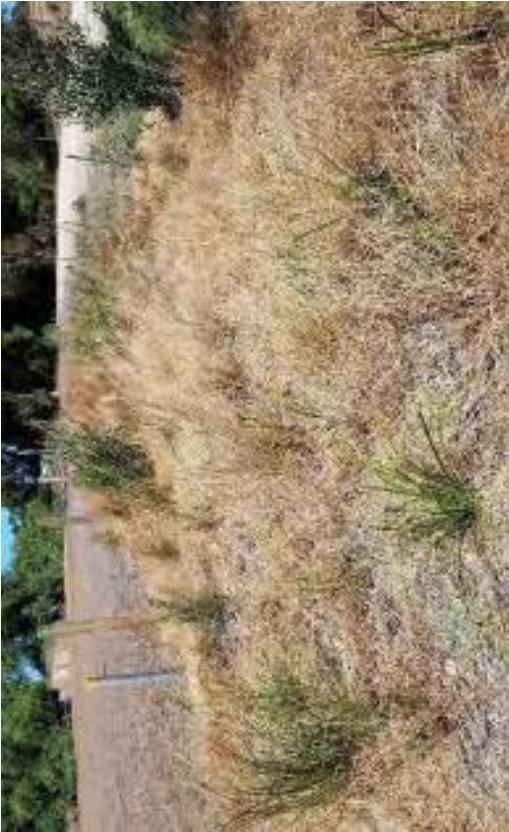
Photo 1: Landale Rd, east side, facing south.
Milestone: 6 months	Target: 80% survival		
	Date: 06/03/2018		
		Generally good survival and moderate growth. An area (9 m x 5 m) above the pipe alignment has only 50 % survival and requires replanting. Estimated survival is 95 %.

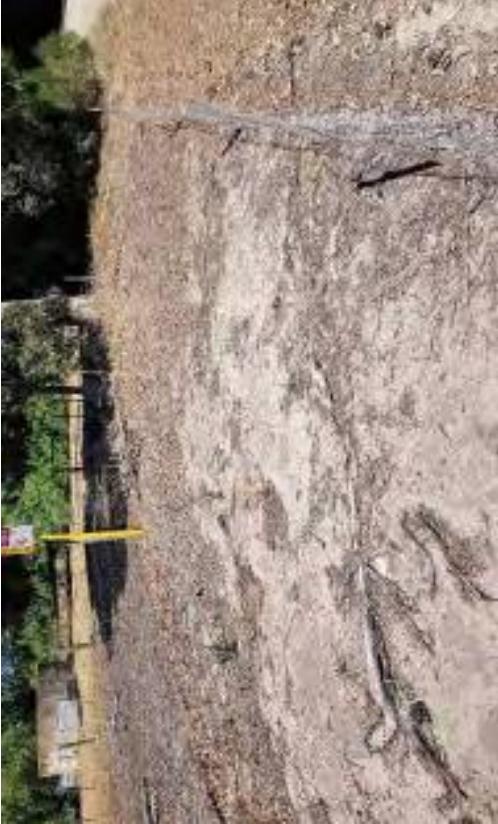
<p>Photo 2: Landale Rd, east side, facing south, area requiring replanting.</p>

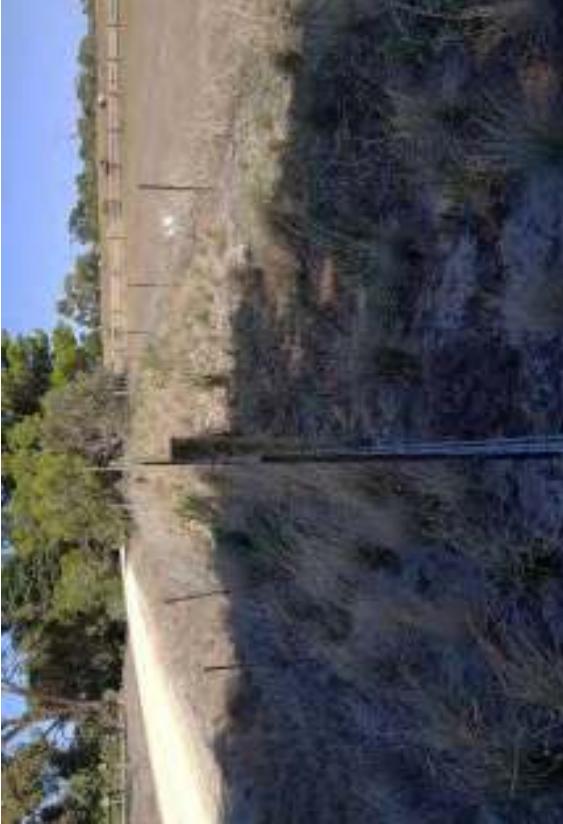
<p>Photo 3: Landale Rd, west side, facing south</p>

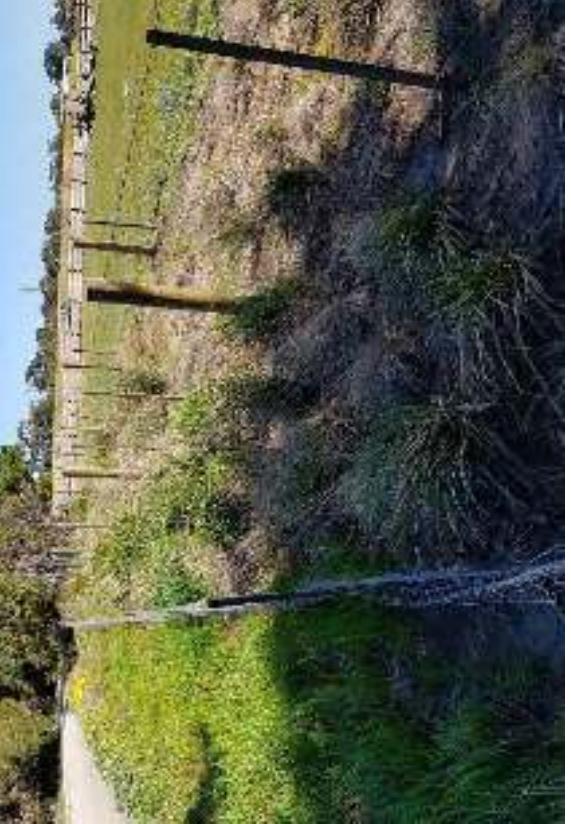
ESSO PIPELINE REPLACEMENT PROJECT	REVEGETATION RECORD
<p>Milestone: 12 months Target: 60% cover over 90% area Date: 13/09/2018</p> <p>Survival on both roadsides is good, with significant growth observed. Cover is greater than 60% across the site.</p>

<p>Photo 5: Landale Rd, west side, facing south</p>

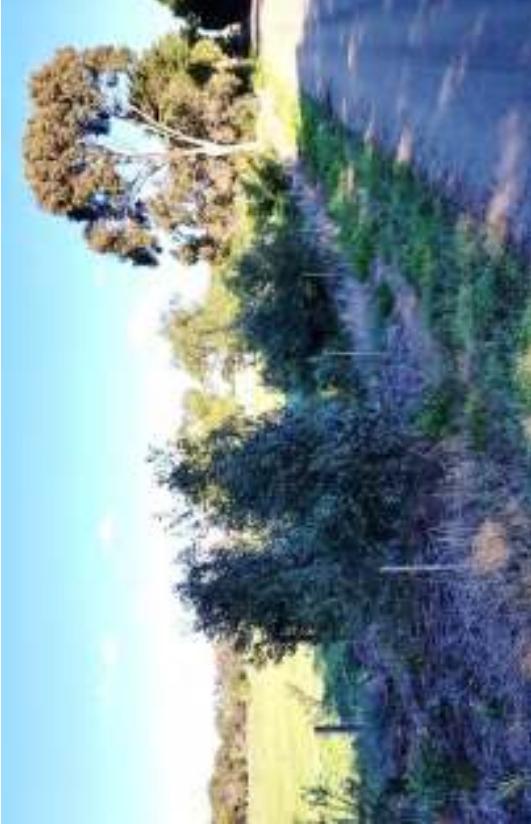
ESSO PIPELINE REPLACEMENT PROJECT	REVEGETATION RECORD
<p>Milestone: 2 years Target: 90% survival Date: 08/08/2019</p> <p>Survival on both roadsides is good, with >90% of the expected plant density within the revegetation area.</p>

<p>Photo 6: Landale Rd, east side, facing south.</p>

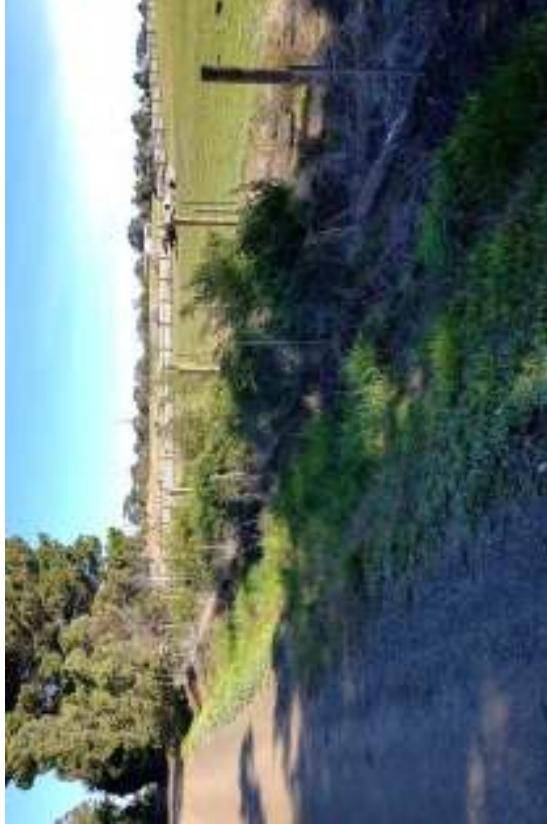
<p>Photo 7: Landale Rd, west side, facing south</p>

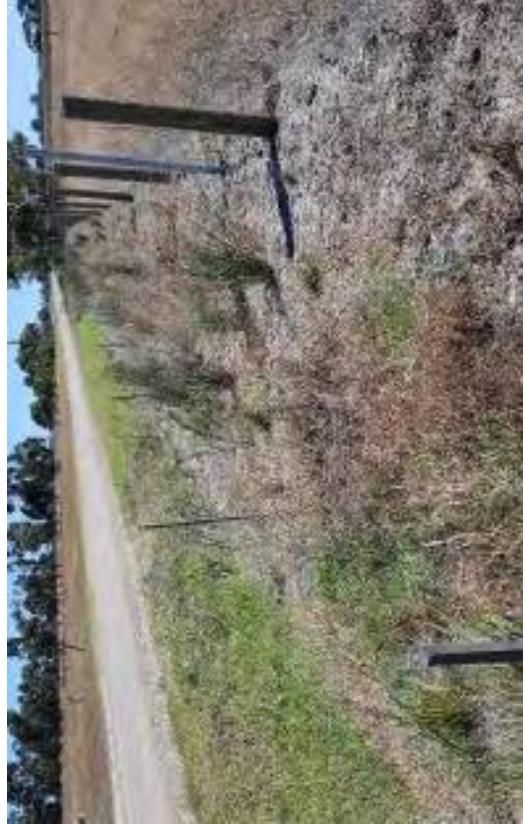
Date: 06/03/2018	Pasture well established. Generally good survival of planted stock, an area (2.5 m x 3 m) at eastern end requires replanting. Estimated survival of planted stock is 90%. Rabbit fencing in place.

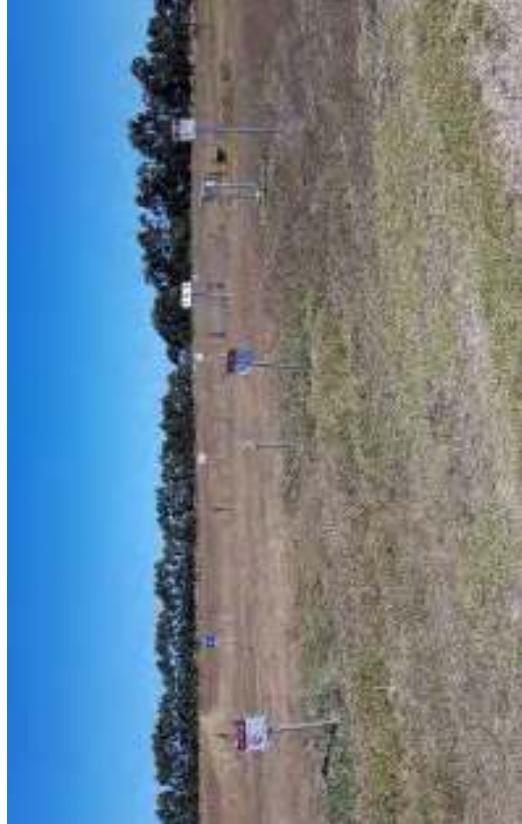
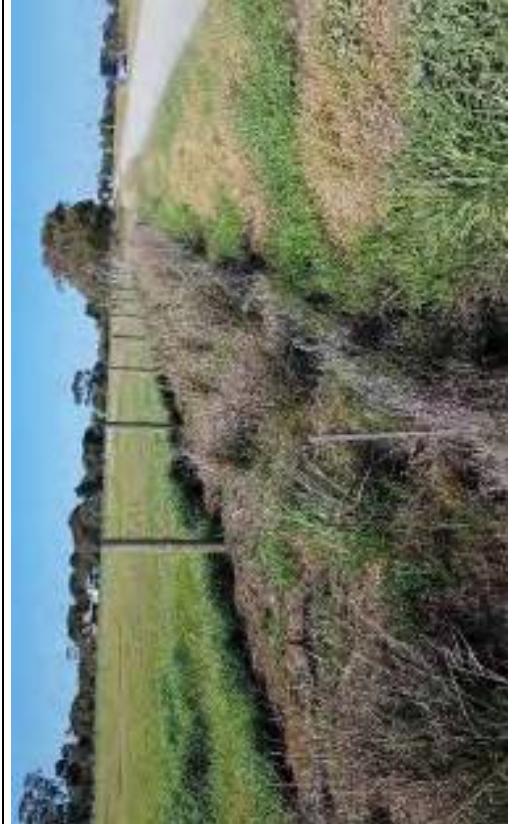
ESSO PIPELINE REPLACEMENT PROJECT	REVEGETATION RECORD	Photo 2: Lynes Rd. southern roadside, facing southwest.	Milestone: 12 months Target: 60% cover over 90% area Date: 13/09/2018 Pasture well established. Planted tubestock, has generally good survival and growth. Overall cover is greater than 60%.

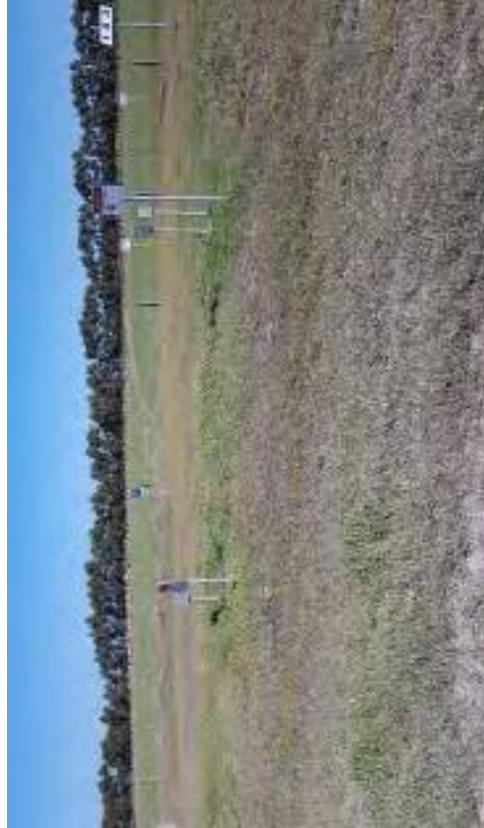
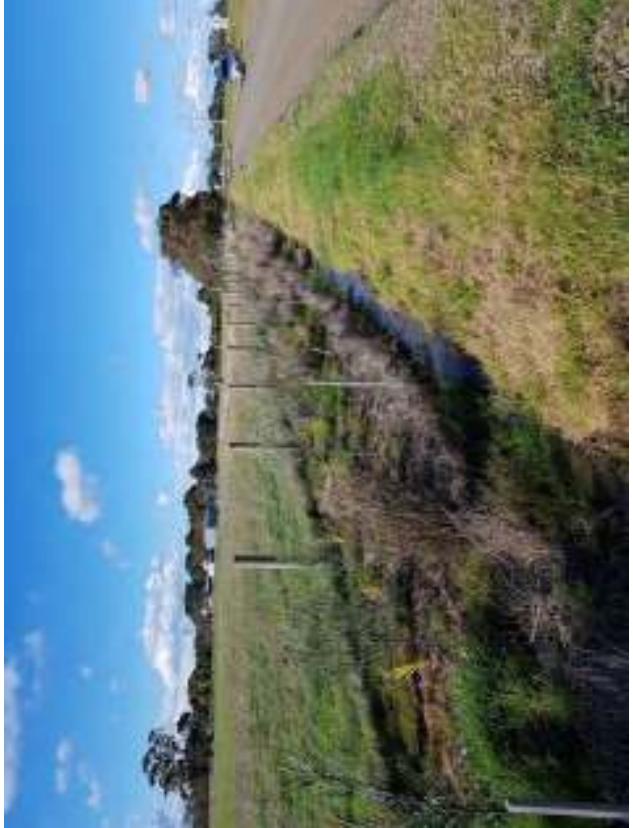
ESSO PIPELINE REPLACEMENT PROJECT	REVEGETATION RECORD	Photo 4: Lynes Rd. southern roadside, facing southwest.	Photo 5: Lynes Rd. Northern roadside, facing east. <p>Milestone: 2 years Target: 90% survival Date: 08/08/2019</p> <p>Planted tubestock has generally good survival and growth. With maintenance planting, this area has >90% of the expected plant density within the revegetation area.</p> <p>Adjacent pasture well established.</p>

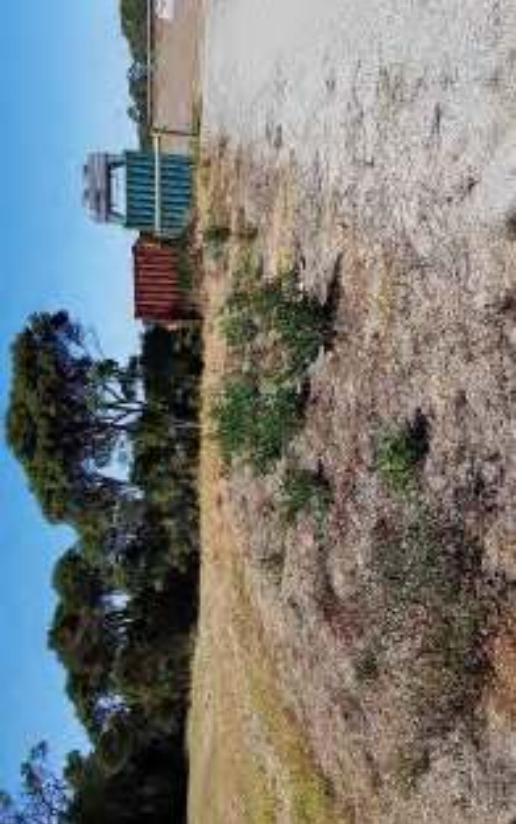
MONITORING POST PLANTING Milestone: 6 months Target: 80% survival Date: 06/03/2018	<p>Photo 1: Fisheries Rd. East side, facing north</p>

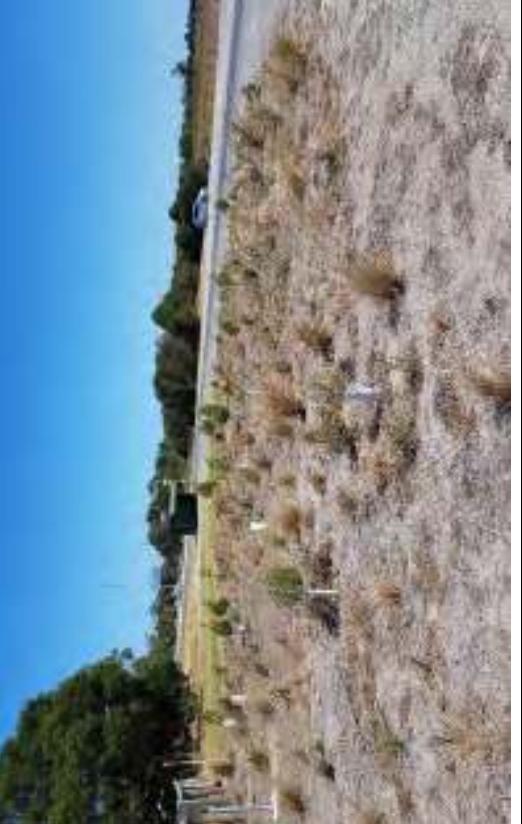
<p>Photo 2: Fisheries Rd. East side, facing south</p>

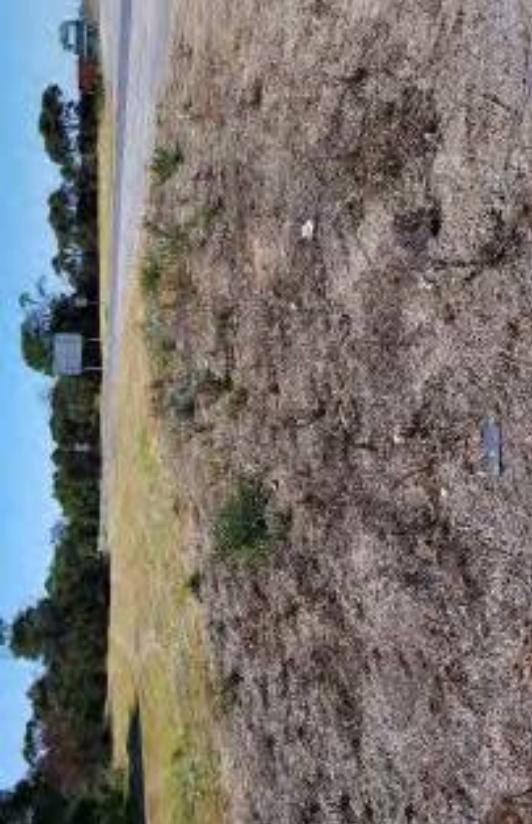
<p>Photo 4: Fisheries Rd. west side, facing south</p>

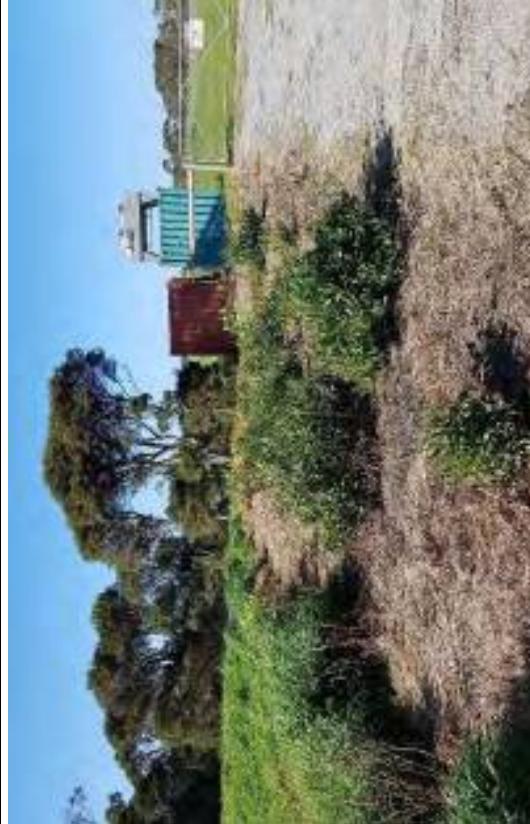
<p>MONITORING POST PLANTING</p> <p>Milestone: 12 months Target: 60% cover over 90% area Date: 13/09/2018</p> <p>Generally good survival and growth, particularly on the eastern roadside. Overall cover estimated at ~60%.</p>	<p>Photo 5: Fisheries Rd. East side, facing north</p>

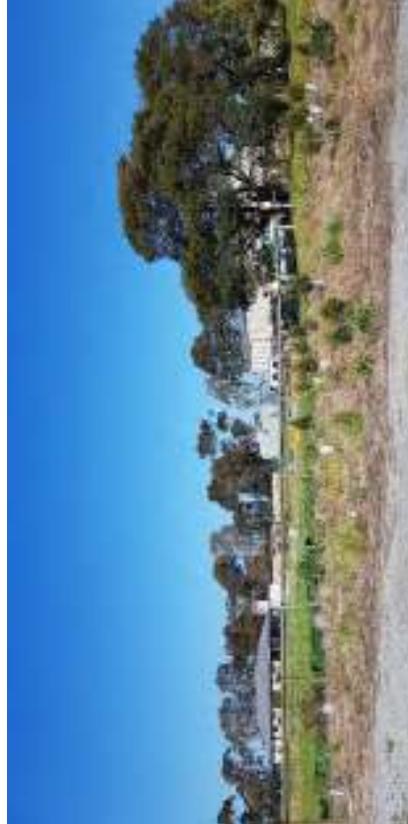
<p>Photo 6: Fisheries Rd. East side, facing south</p>

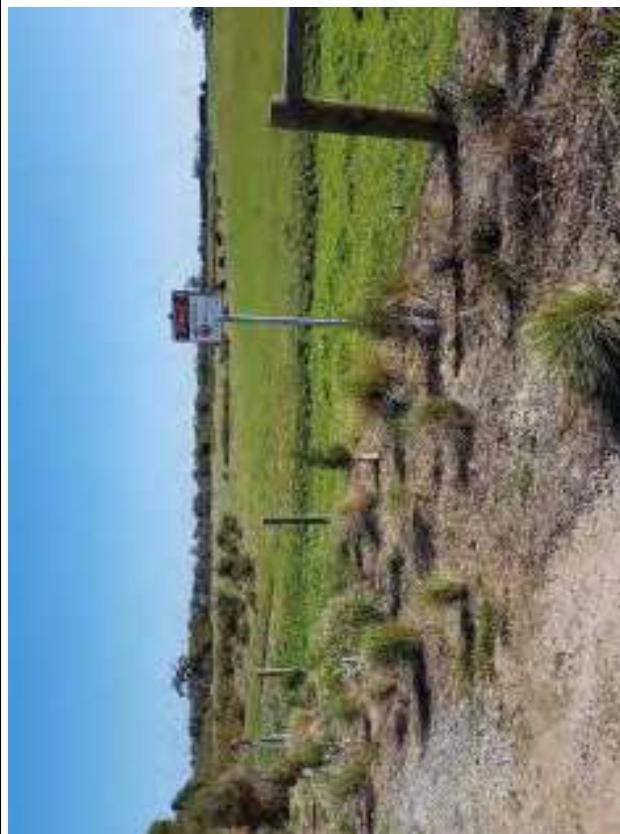
<p>Photo 7: Fisheries Rd. west side, facing south</p>

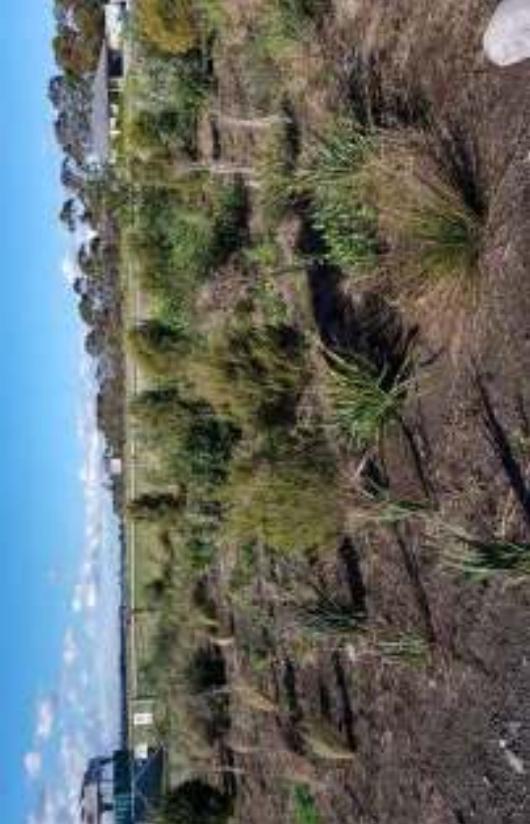
MONITORING POST PLANTING Milestone: 2 years Target: 90% survival Date: 08/08/2019	<p>The survival of original plants is ~80-90%. With maintenance planting, this area has >90% of the expected plant density within the revegetation area.</p> <div style="display: flex; align-items: center; justify-content: space-between;"> <div style="flex: 1;">

</div> <div> Photo 8: Fisheries Rd. East side, facing east </div> </div> <div style="display: flex; align-items: center; justify-content: space-between;"> <div style="flex: 1;">

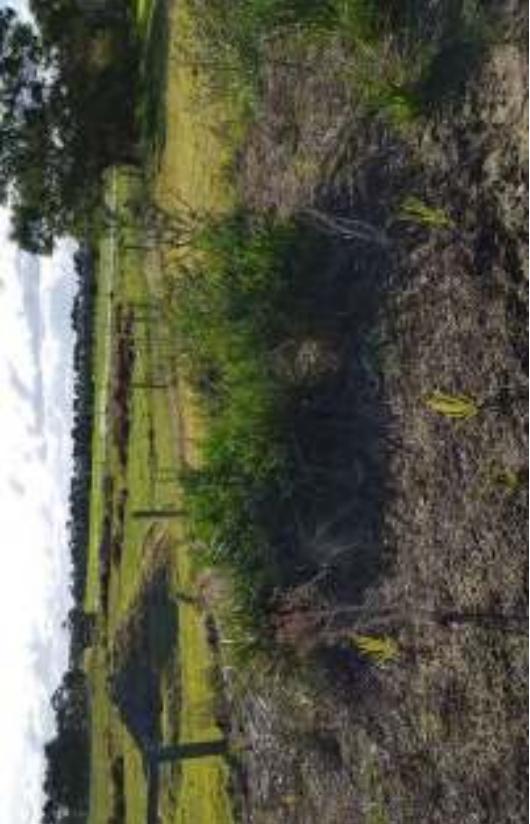
</div> <div> Photo 9: Fisheries Rd. west side, facing north </div> </div>

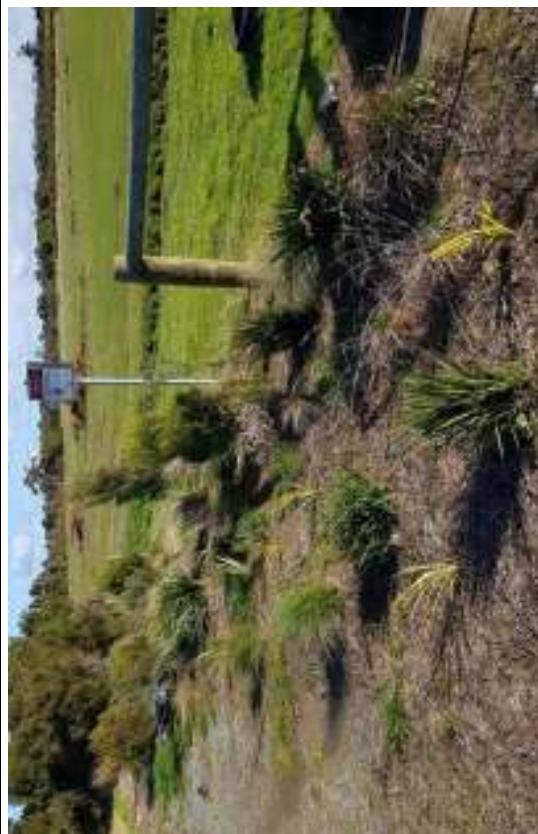
Photo 10: Fisheries Rd. west side, facing south
---------------------------------	--

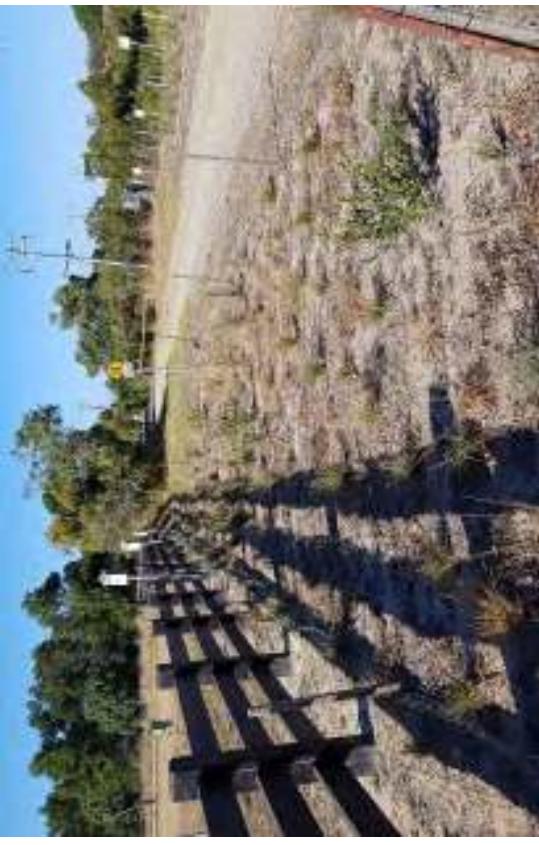
MONITORING POST PLANTING <p>Milestone: 6 months Target: 80% survival Date: 09/03/2018</p> <p>Very high survival of planted stock, especially west to the of Callanan's Lane. Estimated survival is 95%. Melbourne Water easement to the west of Callanan's Lane has again been mowed, presumably as part of their routine easement maintenance.</p>	<p>Photo 1: Callanan's Lane. Eastern roadside, facing south.</p>

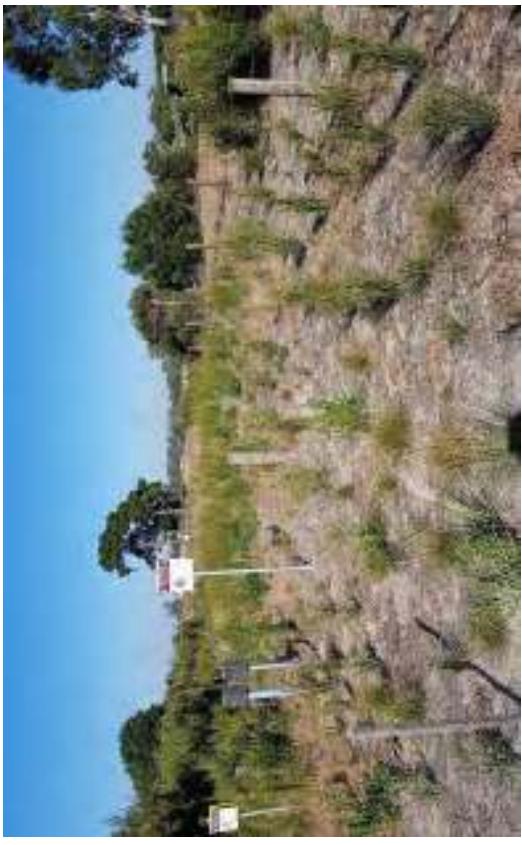
<p>ESSO PIPELINE REPLACEMENT PROJECT</p>	<p>REVEGETATION RECORD</p>	<p>ESSO</p>
<p>MONITORING POST PLANTING</p>	<p>Photo 3: Callanan's Lane. Western roadside, mowed Melbourne Water easement, facing northwest.</p>

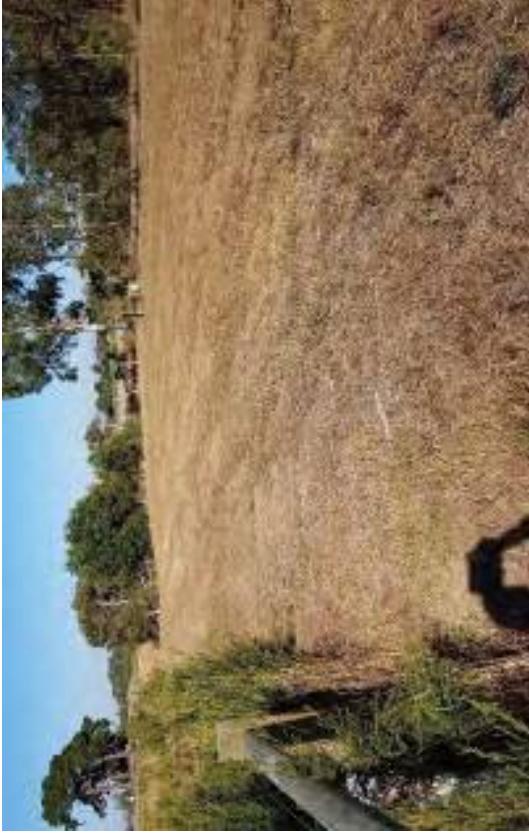
<p>Photo 4: 50 m west of Callanan's Lane, facing southwest.</p>

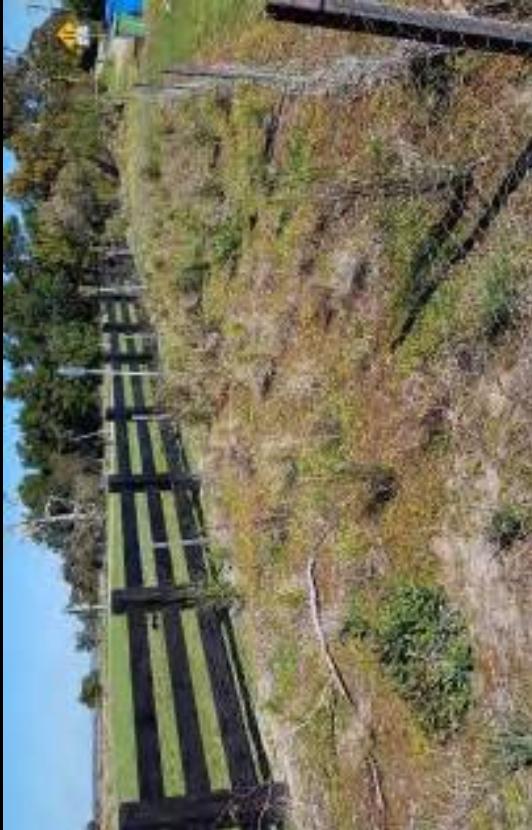
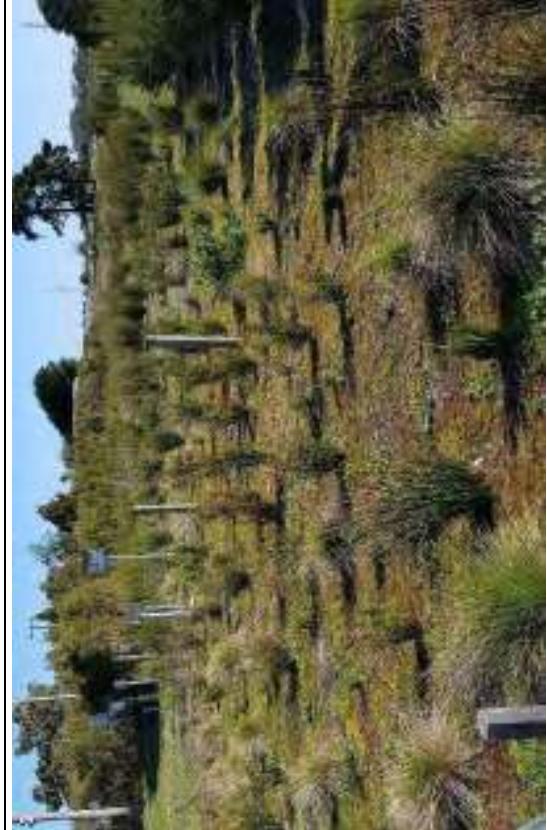
ESSO PIPELINE REPLACEMENT PROJECT	MONITORING POST PLANTING	REVEGETATION RECORD
	<p>Milestone: 12 months Target: 60% cover over 90% area Date: 13/09/2018</p> <p>Survival on both sides of Callamans Lane is high, with plants on the eastern side having grown more. Overall cover is greater than 60% across the site.</p>

<p>Photo 5: Callanan's Lane. Eastern roadside, facing south.</p> <p>Photo 6: Callanan's Lane. Western roadside, facing west.</p>

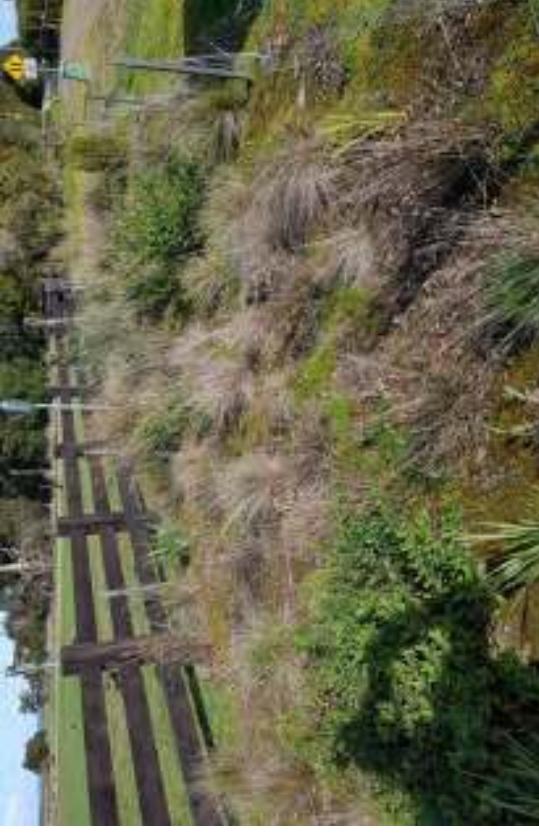
Milestone: 2 years Target: 90% survival Date: 08/08/2019	<p>Photo 7: Callanan's Lane. Eastern roadside, facing south.</p>

<p>Photo 8: Callanan's Lane. Western roadside, facing west.</p>

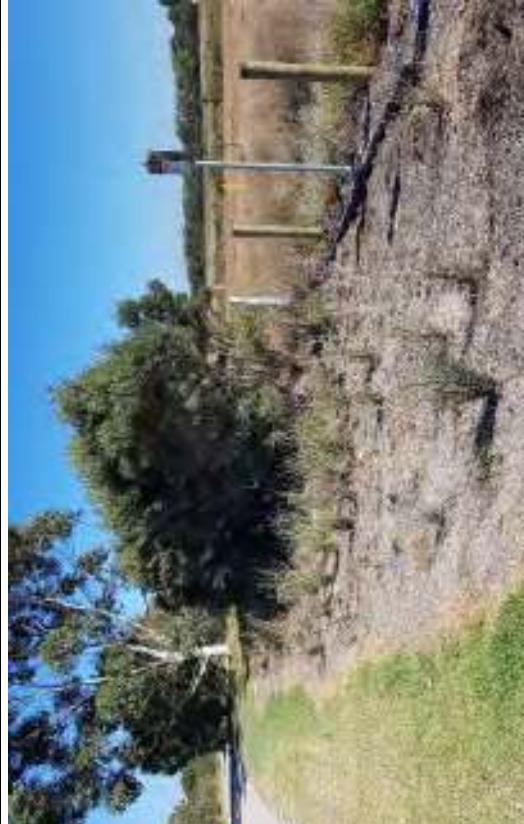
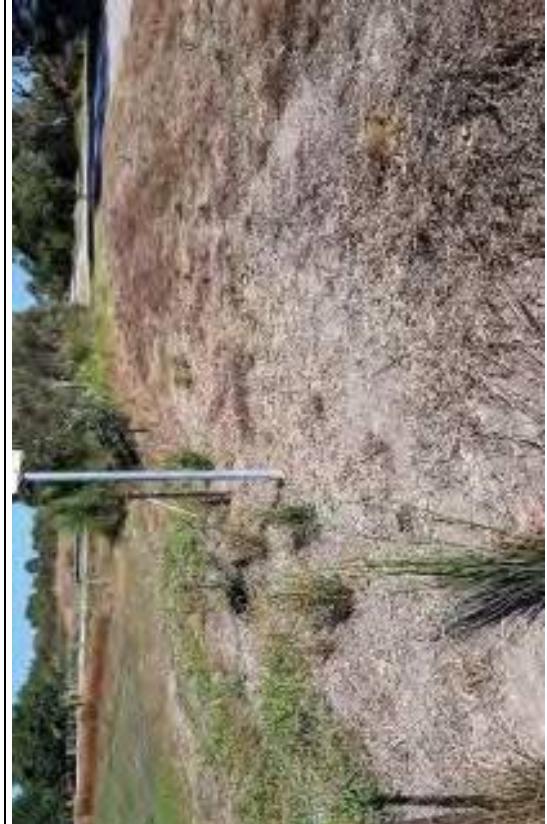
Milestone: 6 months Target: 80% survival Date: 09/03/2018	<p>Market garden remains fallow.</p> <p>Generally good survival of planted stock, overall estimated at 85%.</p> <p>Small area (2 m x 2 m) of rabbit damage on the northern roadside.</p> <p>Southern roadside has been mowed (possibly by adjacent landowner or council as part of maintenance of roadside) although mowed planted grasses persist.</p>

<p>Photo 1: South Boundary Rd. Northern roadside, facing west. Area of rabbit damage in foreground.</p> <p>Photo 2: South Boundary Rd. southern roadside. Mowed area to the left of picture.</p>

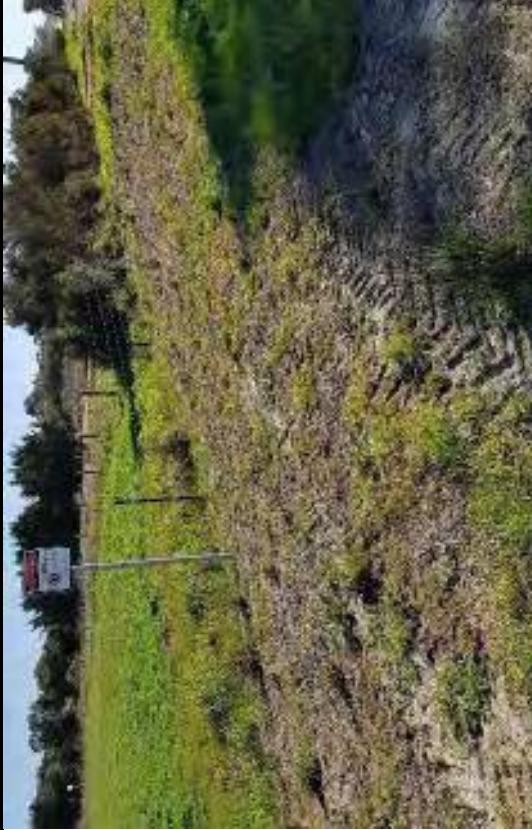
Milestone: 12 months Target: 60% cover over 90% area Date: 13/09/2018	<p>Pasture has begun to establish within the former market garden to the south. Survival and growth on the southern roadside is low, with pasture grasses beginning to encroach. Cover is less than 50%. On the northern roadside, survival is generally good, with estimated cover at ~ 60%.</p>

<p>Photo 3: South Boundary Rd. Northern roadside, facing west.</p>

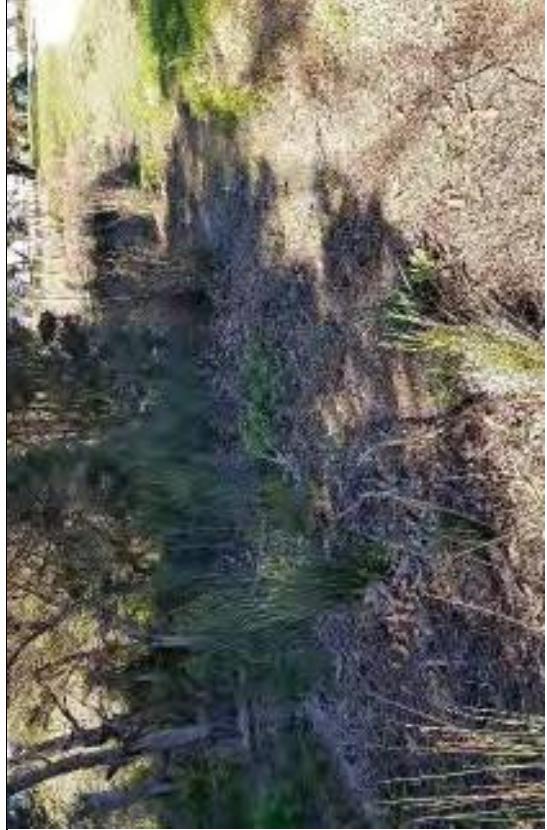
<p>Photo 4: South Boundary Rd. southern roadside.</p>

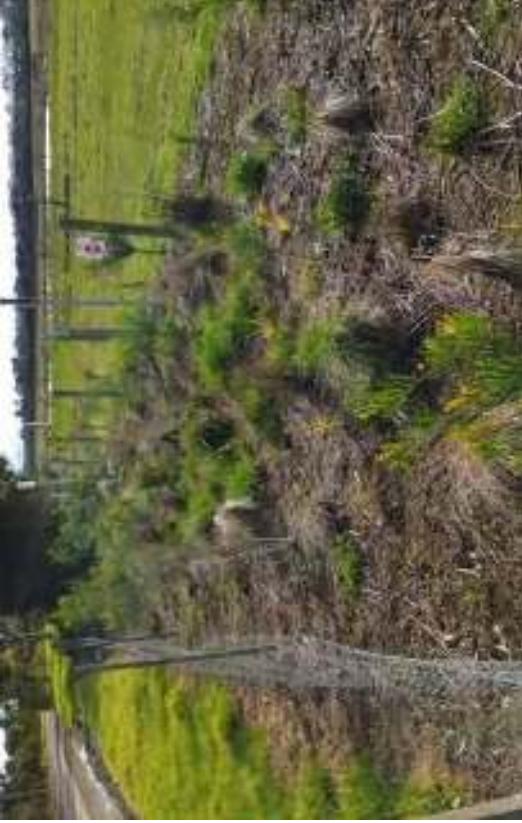
ESSO PIPELINE REPLACEMENT PROJECT		REVEGETATION RECORD	ESSO
MONITORING POST PLANTING			
Milestone: 2 years Target: 90% survival Date: 08/08/2019	Revegetation on the southern roadside is much improved following the installation of rabbit fencing. With maintenance planting, this area has >90% of the expected plant density within the revegetation area. Grasses and rushes have undergone seasonal senescence and winter dormancy, but will increase coverage in spring.

Photo 5: South Boundary Rd. Northern roadside, facing west.

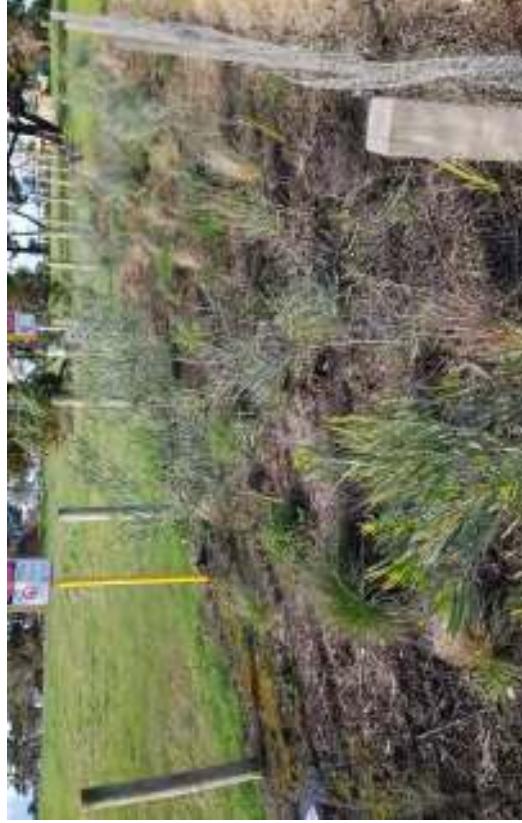
Photo 6: South Boundary Rd. Northern roadside, facing east.

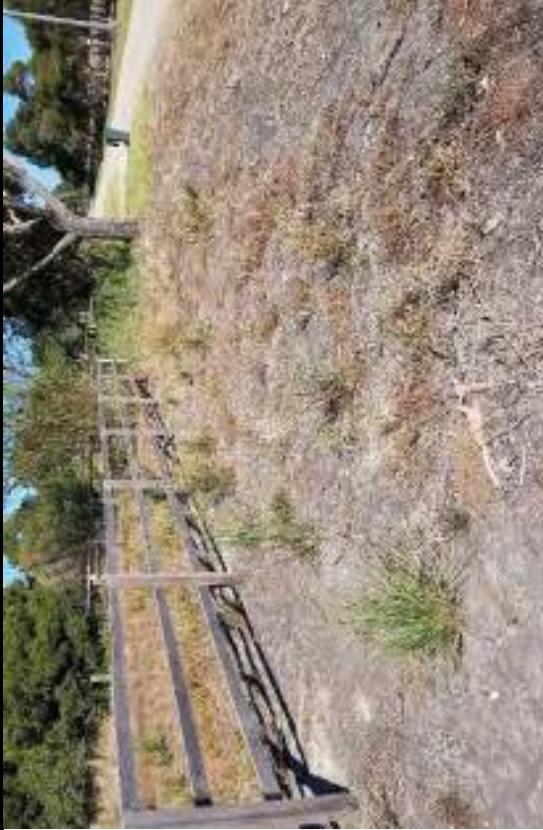
ESSO PIPELINE REPLACEMENT PROJECT	REVEGETATION RECORD	
MONITORING POST PLANTING	<p>Milestone: 6 months Target: 80% survival</p> <p>Date: 09/03/2018</p> <p>Pasture established. Patchy survival of planted stock, overall estimated at 80%, with additional reestablishment of native reeds (<i>Phragmites australis</i>).</p>

<p>Photo 1: Bungower Rd. Southern roadside facing west.</p>

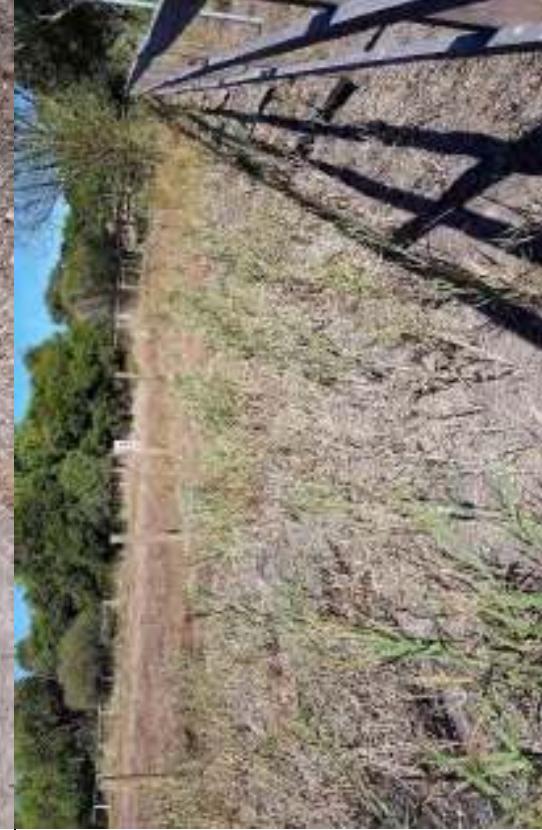
<p>Photo 2: Bungower Rd. Southern side property boundary, facing west.</p>

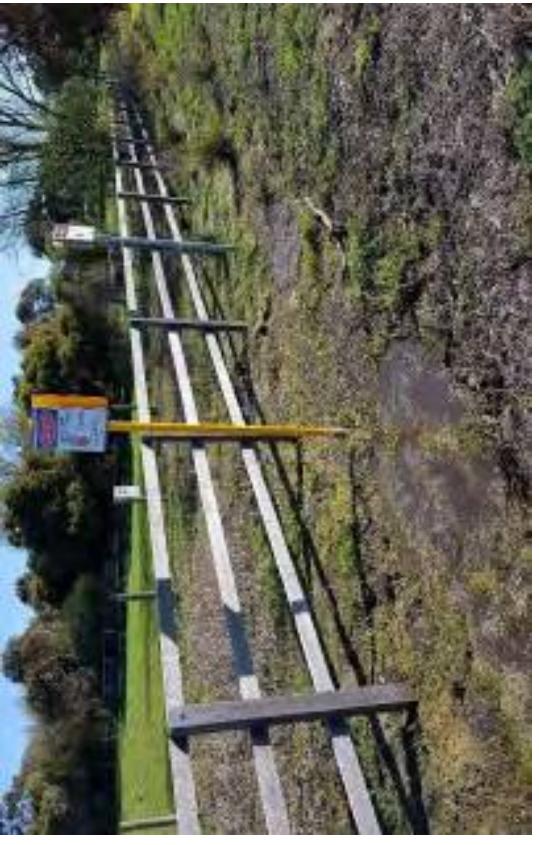
<p>MONITORING POST PLANTING</p> <p>Milestone: 12 months Target: 60% cover over 90% area Date: 13/09/2018</p> <p>Survival of planted stock remains low and patchy. With seasonal dieback of the phragmites reeds, overall cover is estimated at less than 50%.</p>	<p>Photo 3: Bungower Rd. Southern roadside facing southwest.</p>

<p>Photo 4: Bungower Rd. Southern side property boundary, facing west.</p>

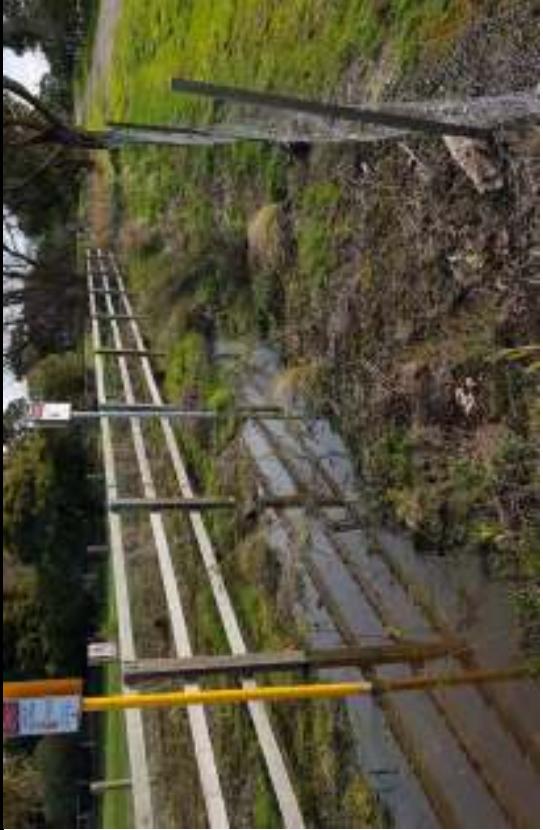
Milestone: 2 years Target: 90% survival Date: 08/08/2019	<p>Cover remains low, however, with maintenance planting, this area has >90% of the expected plant density within the revegetation area. Grasses, rushes and reeds have undergone seasonal senescence and winter dormancy, but will increase coverage in spring.</p>

<p>Photo 5: Bungower Rd. Southern roadside facing southwest.</p>

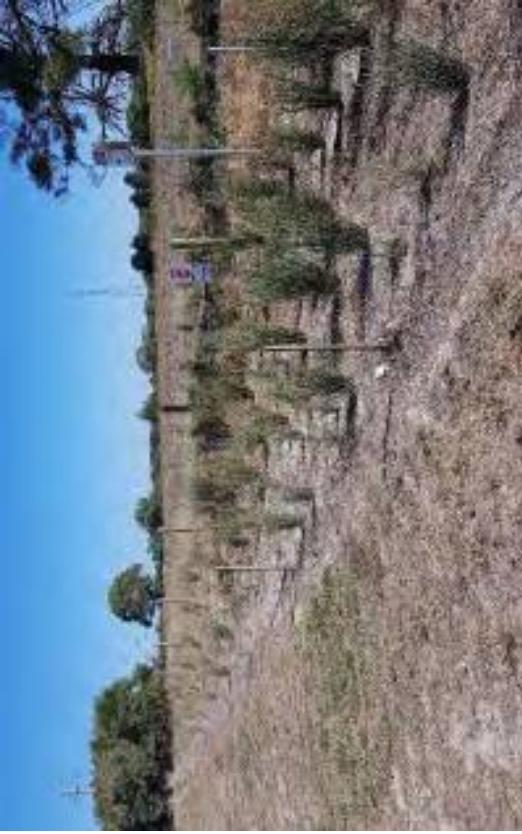
<p>MONITORING POST PLANTING</p> <p>Milestone: 6 months Target: 80% survival</p> <p>Date: 09/03/2018</p> <p>Good survival and strong growth across the site. Estimated survival is 95 %.</p>

<p>Photo 1: Pikes Rd, northern roadside, facing west..</p>

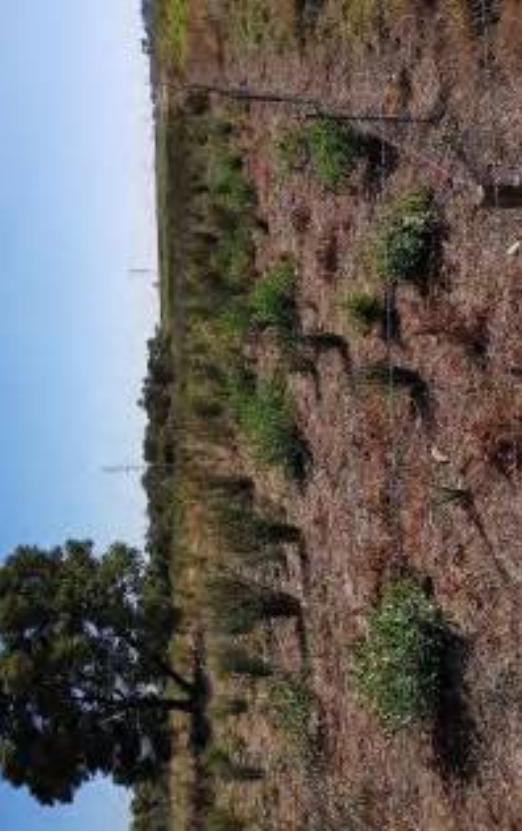
<p>Photo 2: Pikes Rd. Northern side, adjacent property, facing north.</p>

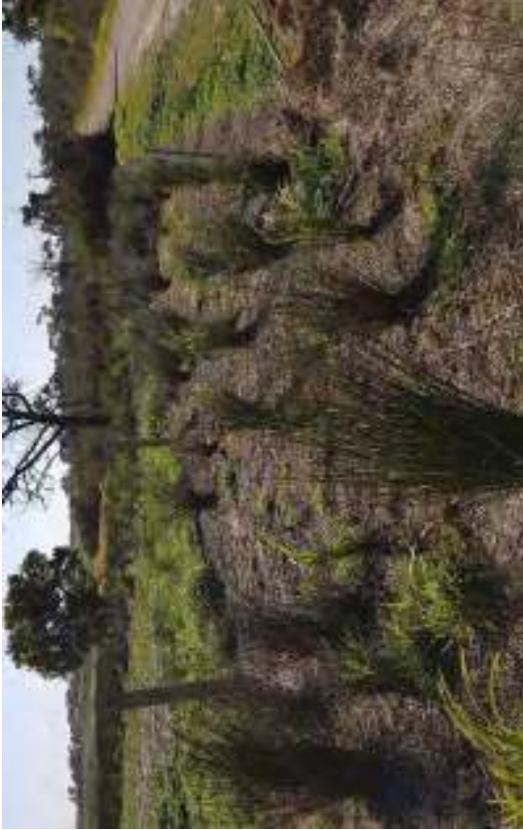
ESSO PIPELINE REPLACEMENT PROJECT	REVEGETATION RECORD	
MONITORING POST PLANTING		
Milestone: 12 months Target: 60% cover over 90% area Date: 14/09/2018	<p>Good survival and growth, particularly away from the roadside. Overall cover is assessed as greater than 60 %.</p>

<p>Photo 3: Pikes Rd, northern roadside, facing east.</p>

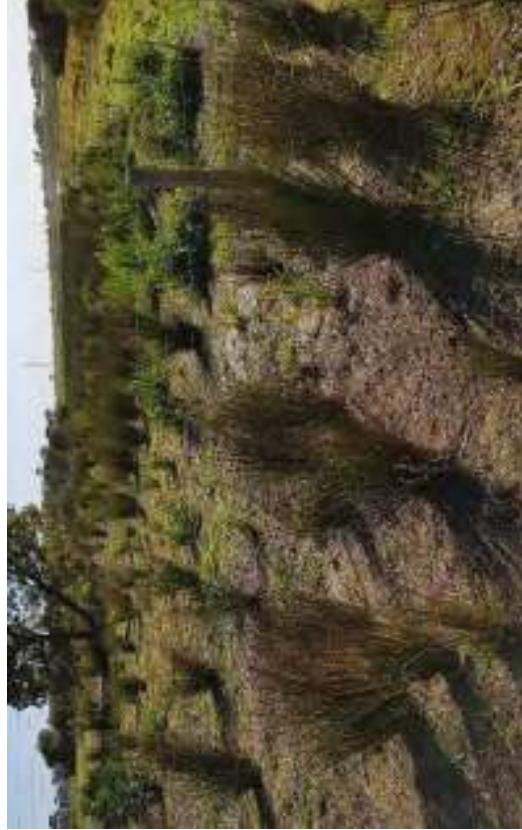
<p>Photo 4: Pikes Rd. Northern side, adjacent property, facing north.</p>

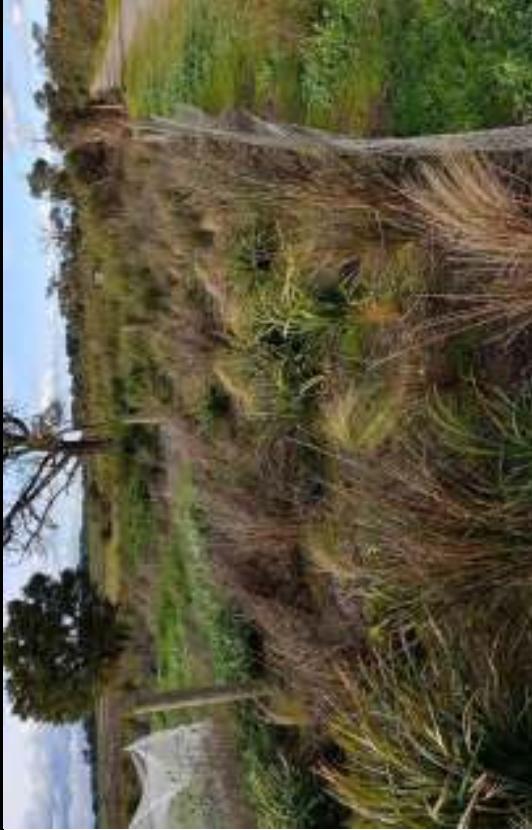
<p>Milestone: 2 years Target: 90% survival Date: 08/08/2019</p> <p>Good survival and growth across the site, with >90% of the expected plant density.</p>	<p>Photo 5: Pikes Rd, northern roadside, facing east.</p>

<p>Photo 6: Pikes Rd. Northern side, adjacent property, facing north.</p>

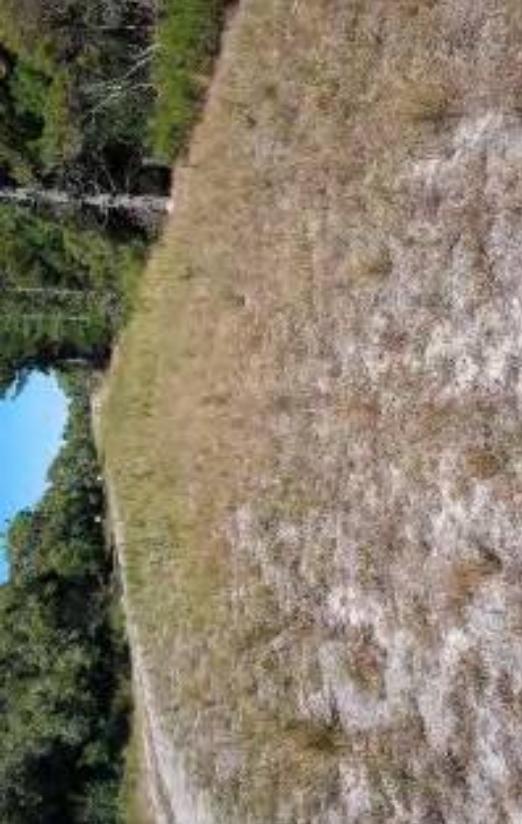
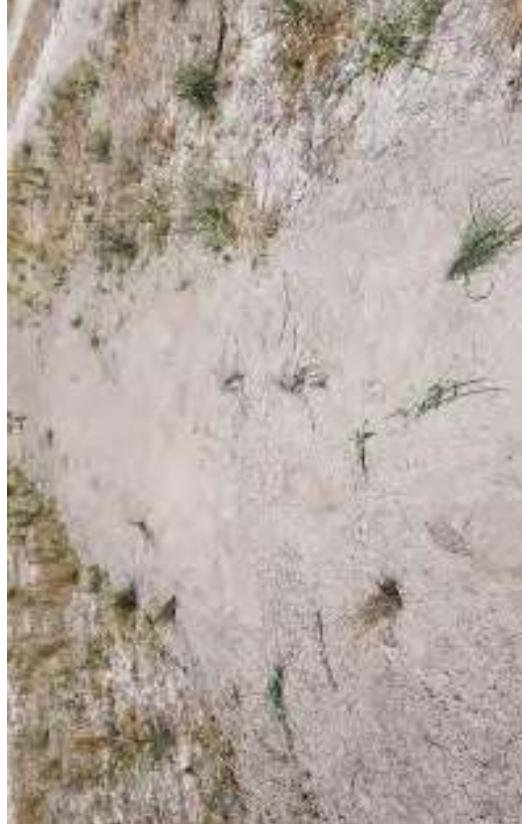
<p>Overall survival is very high, estimated at 95%. A low area (~50 m²) at KP179.7 appears to be periodically inundated and tubestock has not survived. Subsidence repair from KP179.4 to KP180.05 has disturbed a 1 m to 1.5 m wide strip of revegetation. It appears to be primarily topsoil fill rather than reworking of the surface, so many partially buried plants are expected to survive and overall the work will not significantly reduce survival.</p> <p>Growth is reduced under the pine trees at KP180.3 due to smothering and chemical suppression from pine needles. This would have occurred pre-construction.</p>

<p>Photo 1: BlueScope revegetation. KP179.4</p> <p>Photo 2: BlueScope revegetation. KP179.75, subsidence repair with partially buried tubestock.</p>

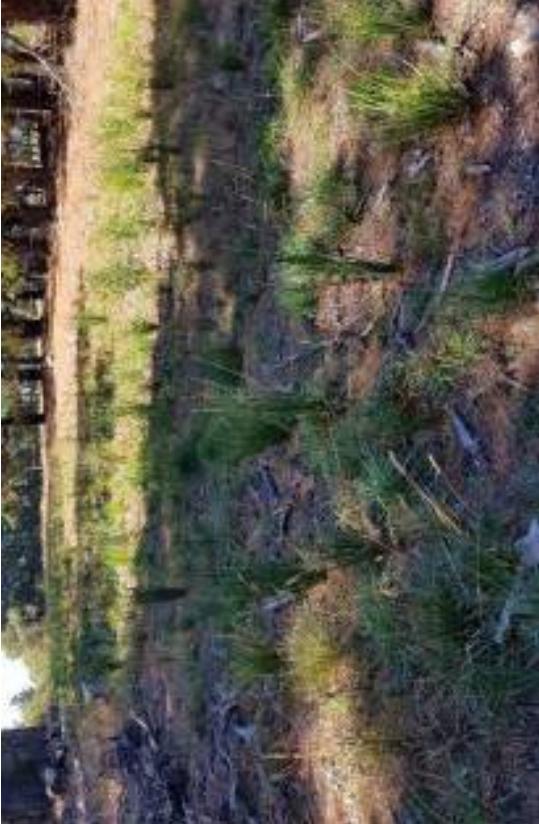
<p>Photo 3: BlueScope revegetation. KP180.35, planting adjacent to pine trees.</p>

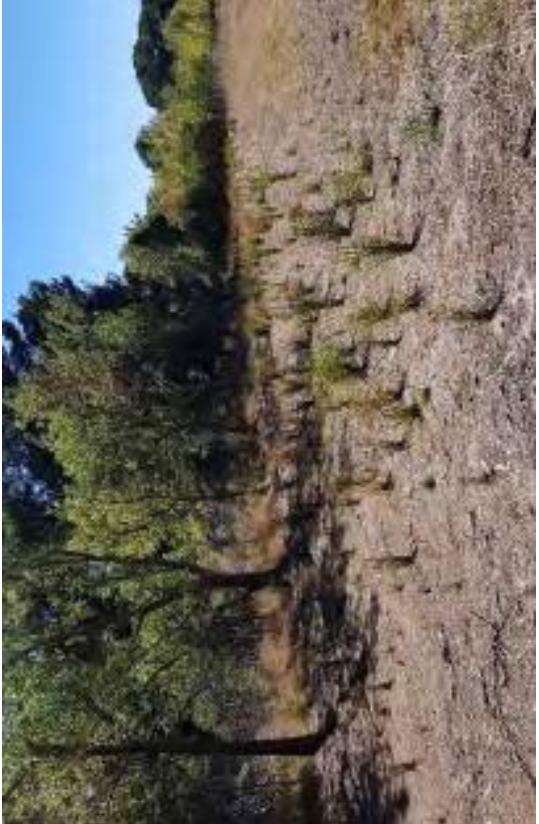
<p>Photo 4: BlueScope revegetation. KP180.55, partial width of Row</p>
