ESSO PIPELINE REPLACEMENT PROJECT	ANNUAL COMPLIANCE REPORT

ESSO PIPELINE REPLACEMENT PROJECT (EPBC 2014/7202)

ANNUAL COMPLIANCE REPORT # 3

EMEL-RPT-355-EN203

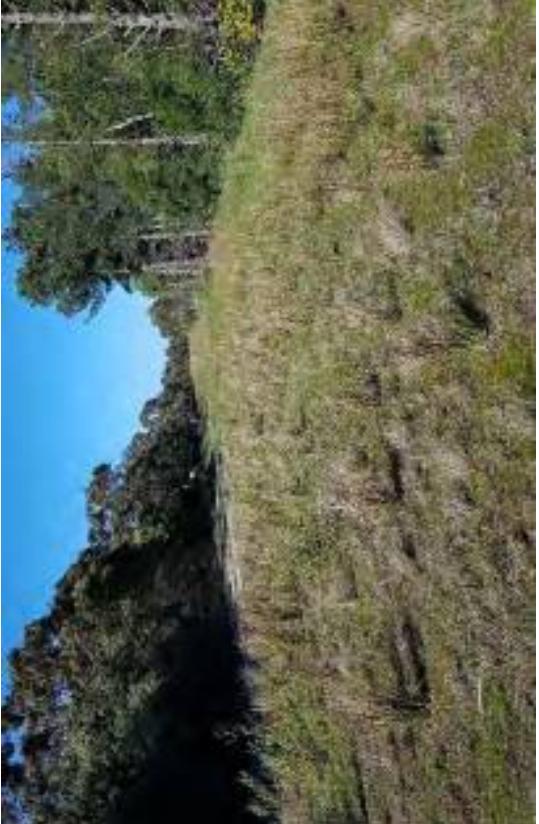
ESSO PIPELINE REPLACEMENT PROJECT	REVEGETATION RECORD
<p>Milestone: 12 months Target: 60% cover over 90% area Date: 14/09/2018</p> <p>Overall survival remains very high. Growth is variable across the different areas of site.</p> <p>KP179.4 – 179.8 – good growth, particularly at the margins of drainage lines, excluding the ephemeral wetland where tubestock has not survived.</p>

<p>Photo 5: BlueScope revegetation. KP179.5</p> <p>KP179.8 to 180.08 – good survival but limited growth, plants appear to have been browsed, and a swamp wallaby was observed feeding on replanting during the survey.</p> <p>KP180.2 to 180.35 – good survival and growth.</p>

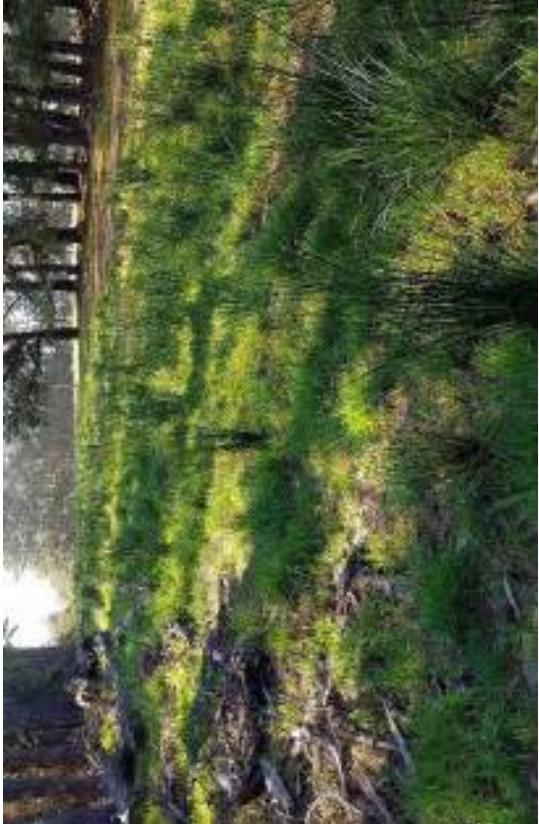
<p data-bbox="283 185 376 614">Photo 7: BlueScope revegetation. KP180.35, planting adjacent to pine trees.</p>

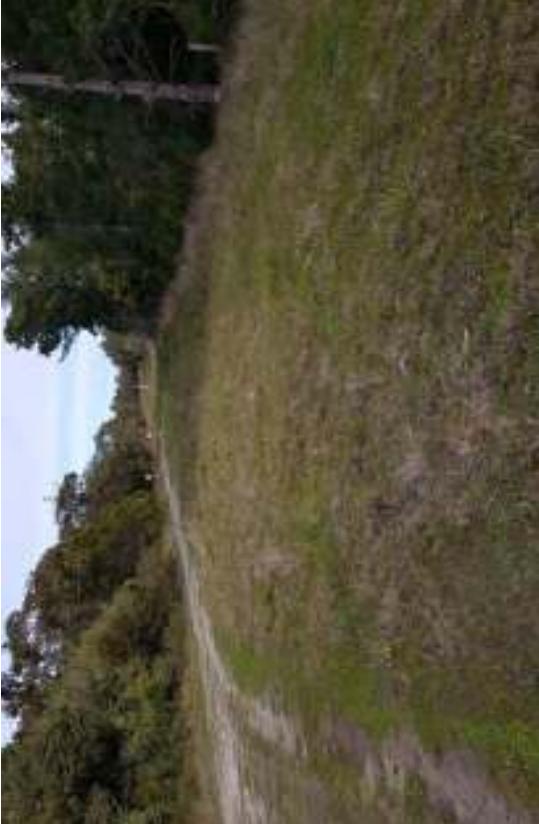
ESSO PIPELINE REPLACEMENT PROJECT	REVEGETATION RECORD
Milestone: 2 years Target: 90% survival Date: Overall this site has >90% of the expected plant density. Growth is variable across the different areas of site. KP179.4 – 179.8 – initial strong growth in this area appears to have been grazed back (wallabies and rabbits). Most plants still surviving, with grasses and rushes in winter dormancy, and will increase coverage in spring.

<p>Photo 9: BlueScope revegetation. KP179.5</p>

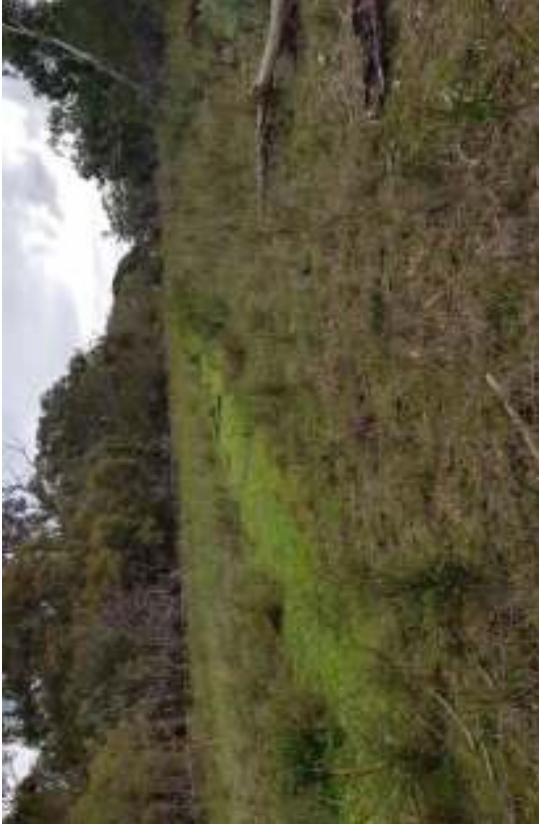
Milestone: 2 years Target: 90% survival Date: Overall this site has >90% of the expected plant density. Growth is variable across the different areas of site. KP179.4 – 179.8 – initial strong growth in this area appears to have been grazed back (wallabies and rabbits). Most plants still surviving, with grasses and rushes in winter dormancy, and will increase coverage in spring.

<p>Photo 10: BlueScope revegetation. KP180.</p>
---	---

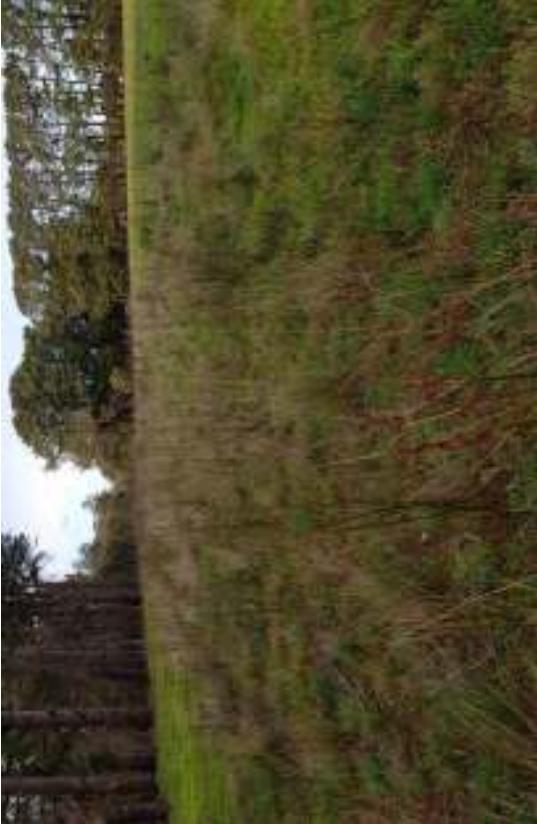
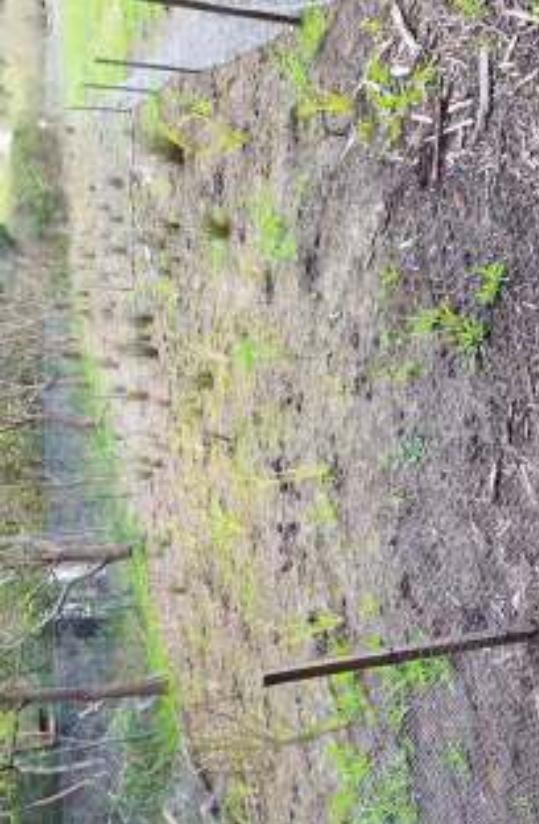
ESSO PIPELINE REPLACEMENT PROJECT	REVEGETATION RECORD	
ESSO	Photo 11: BlueScope revegetation. KP180.35, planting adjacent to pine trees.	Photo 12: BlueScope revegetation. KP180.55, partial width of RoW Area previously grazed by cattle has been replanted
cover until the plants become more established over spring.

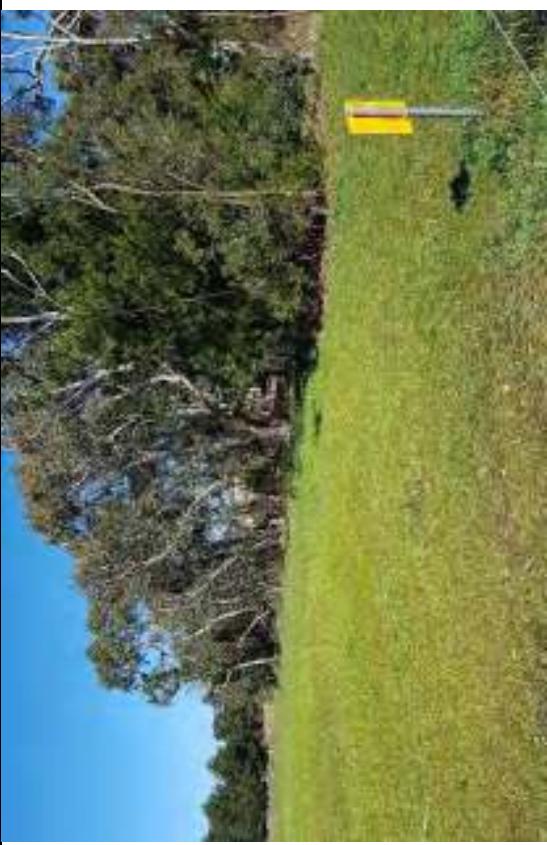
ESSO PIPELINE REPLACEMENT PROJECT	REVEGETATION RECORD
<p>Milestone: 12 months Target: 60% cover over 90% area Date: 14/09/2018</p> <p>Pasture has been established across the site with greater than 60% cover</p>

<p>Photo 2: Thornells Rd revegetation area, facing south</p>

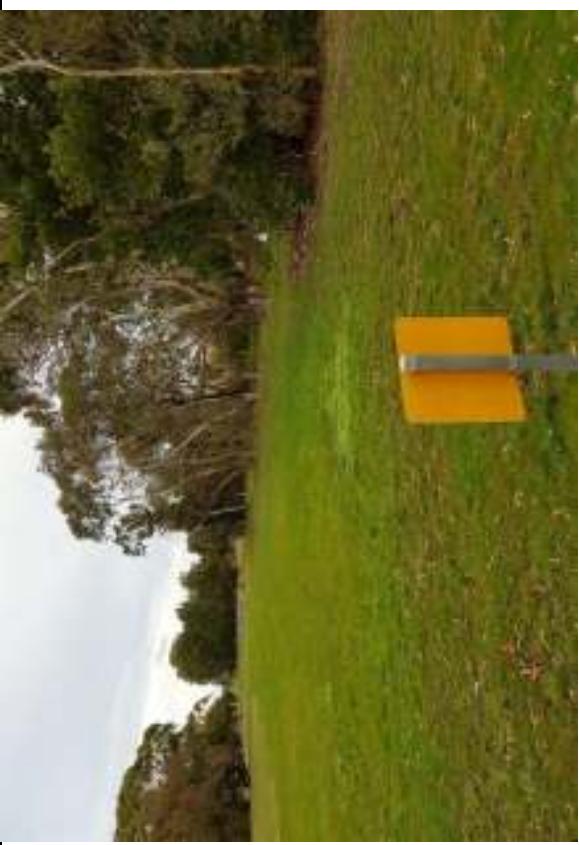
<p>Milestone: 2 years Target: 90% survival Date: 08/08/2019</p> <p>Pasture has been established across the site with ~100% cover</p>

<p>Photo 3: Thornells Rd revegetation area, facing south</p>
---	--
